Preliminary Flood Assessment  
Technical Memorandum  
**Royal Trails Flood Study**

**LAKE COUNTY**  
FLORIDA

**Re: Royal Trails Flood Study  
Preliminary Flood Assessment Technical Memorandum  
County PO # 20701804**

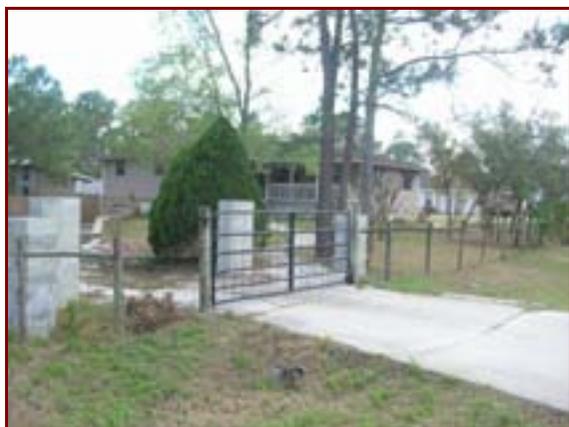
- **30116 Viola Avenue** – Resident reported flooding at her home after the 2004 hurricanes at the November 8<sup>th</sup>, 2007 public meeting. He mentioned during a follow up phone conversation on February 26<sup>th</sup>, 2009 that the property flooded during Tropical Storm Fay (in August 2008) and that flooding problems have occurred after other heavy rain events. During a field visit at the subject residence also on February 26<sup>th</sup>, 2009 a black line was shown that had been spray painted on the cinder blocks under the house to indicate the level that the flood water had reached in 2004. Photos of the property are shown below.

Photo of property looking southwest

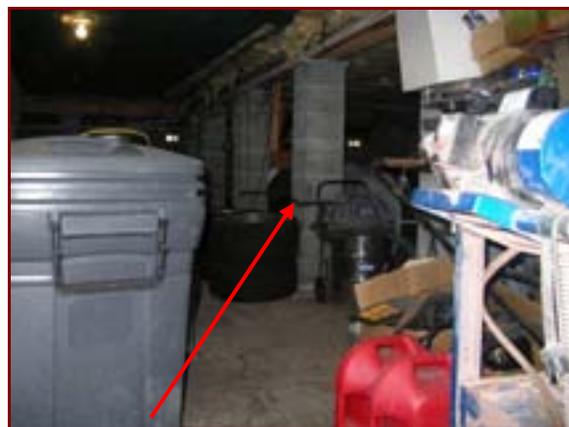
Photo of space under residence and black line indicating flood water level.

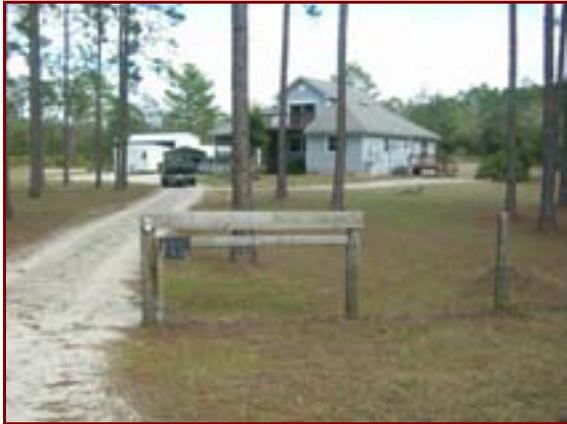
- **42302 West Cashew Ct** – Resident reported prolonged yard flooding at the property after the 2004 hurricanes on a comment form from November 2007. During a field visit to the property on February 26<sup>th</sup>, 2009 the resident mentioned that the flood water had reached the wooden steps in front of the house and would have gotten higher if they had not pumped water from the property. The resident also mentioned that the County built ditch blocks in swale along Cashew Court to divert runoff from the street away from their property. The resident has also built a small berm along the side of the property to block water from coming into the property and brought in fill to raise the driveway. Flooding on the property also occurred during Tropical Storm Fay, but did not last as long as the flooding in 2004. Photos of the property are shown below.

Photo of property looking east

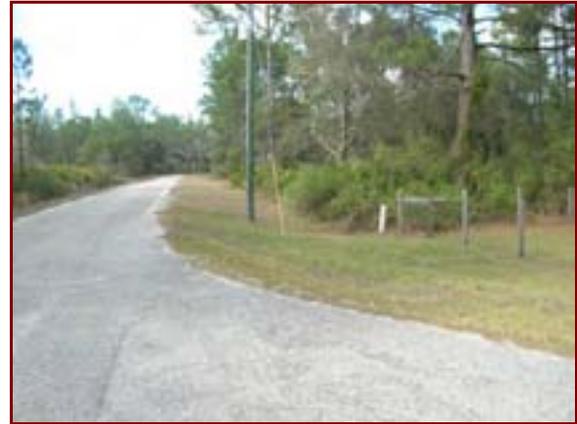
Photo of West Cashew Court swale looking north.

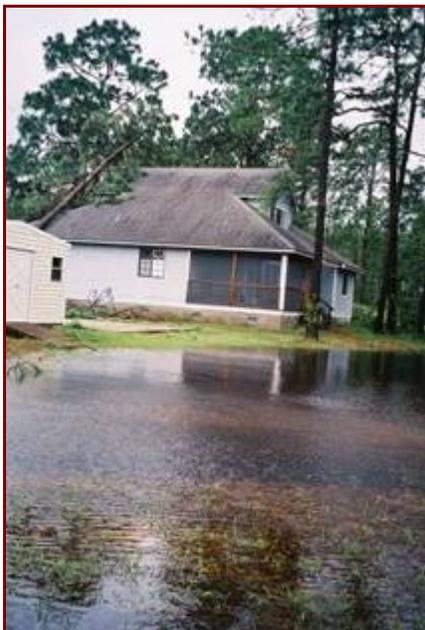
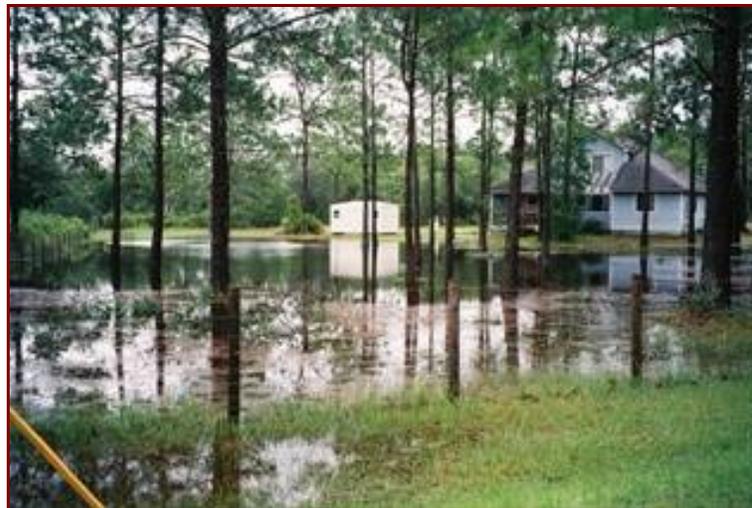
Photos property flooding after Hurricane Frances. (Provided by resident)

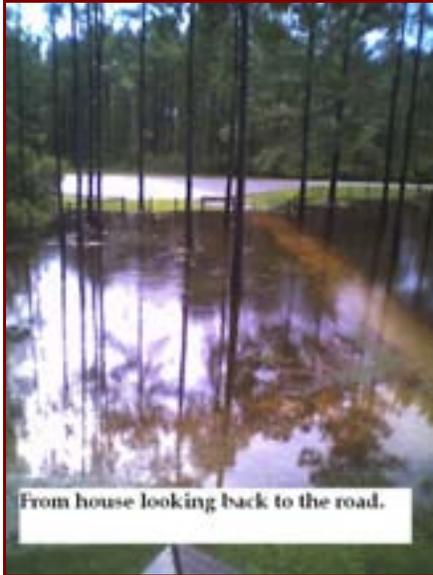
Photo of property after Tropical Storm Fay. (Provided by resident)

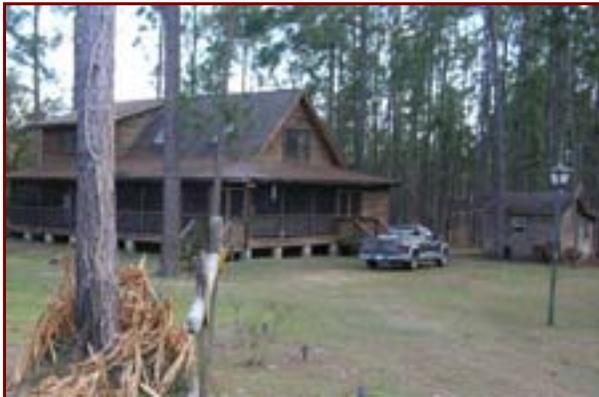
- **41513 Aspen St** – Resident reported flooding at the home after the 2004 hurricanes at the November 8<sup>th</sup>, 2007 public meeting and provided photos of flooding. It was indicated on a comment form that the flooding lasted for almost two years in 2004 and 2005. Attempts to contact the resident for a follow up visit were unsuccessful. Photos of the property are shown below.

Photo looking south at property.

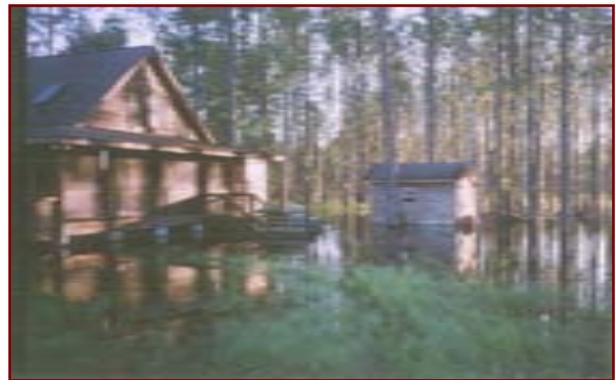
Photo looking south at flooding at property.  
(Provided by resident)

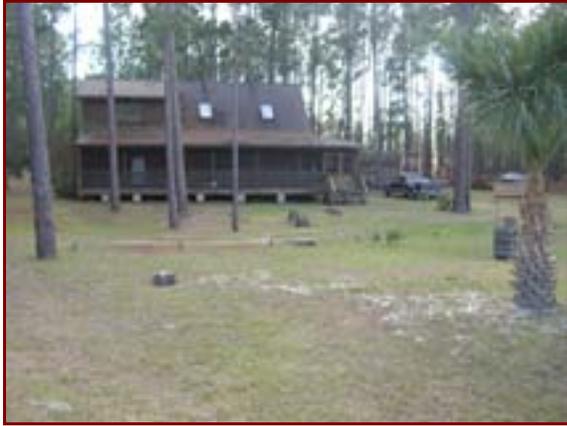
Photo looking southwest at property.

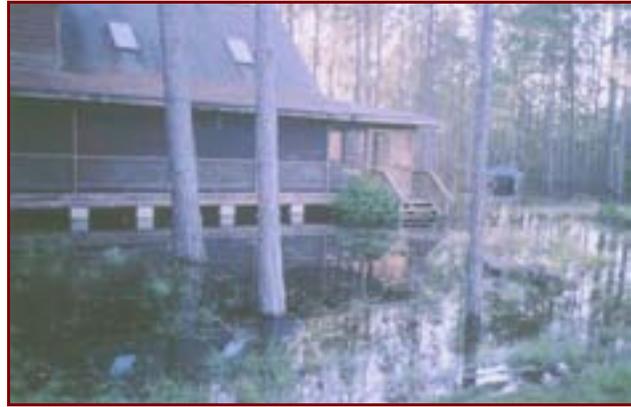
Photo looking west at flooding at property.  
(Provided by resident)

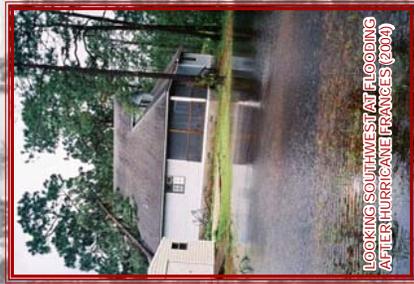
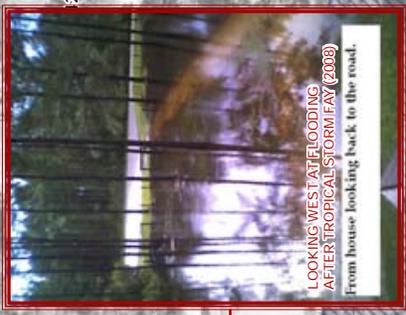
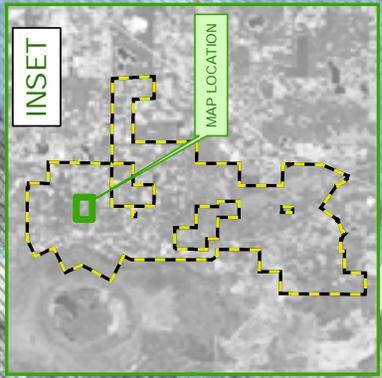
MODELED FLOODPLAIN CONSISTENT WITH LOCATION OF REPORTED FLOODING. FEMA FLOODPLAIN CONSISTENT AS WELL.

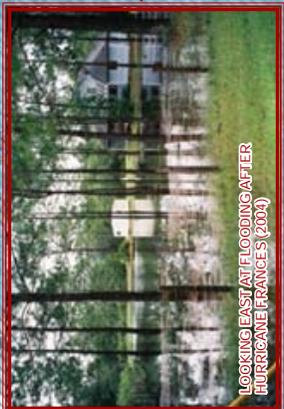
THE RESIDENT MENTIONED THAT THE FLOODING REACHED THE FRONT STEPS DURING THE 2004 HURRICANE SEASON.

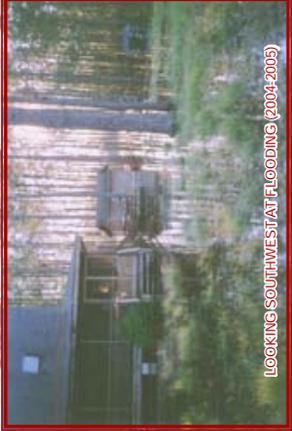
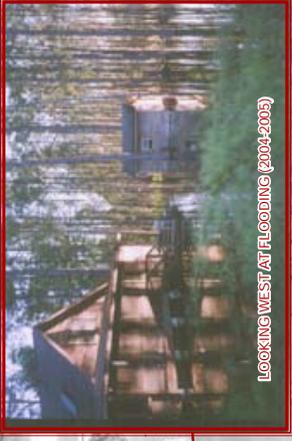
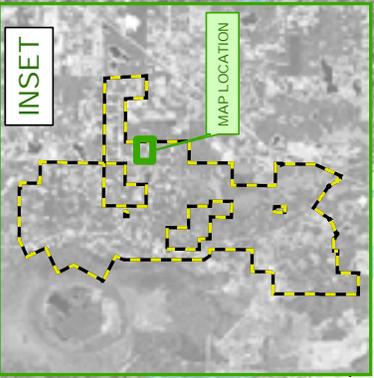
MODELED FLOODPLAIN CONSISTENT WITH LOCATION OF REPORTED FLOODING, FEMA FLOODPLAIN NOT CONSISTENT.

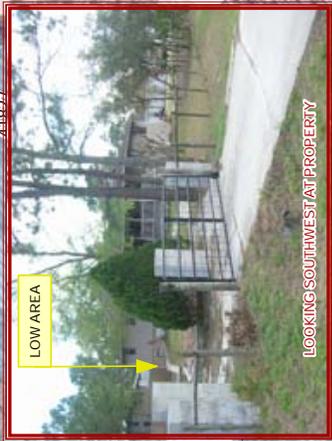
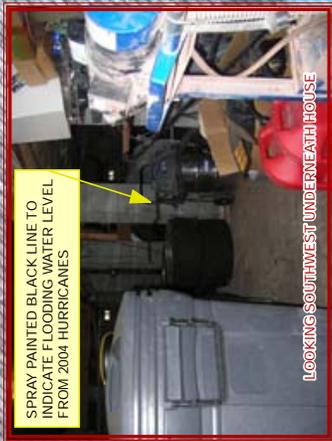
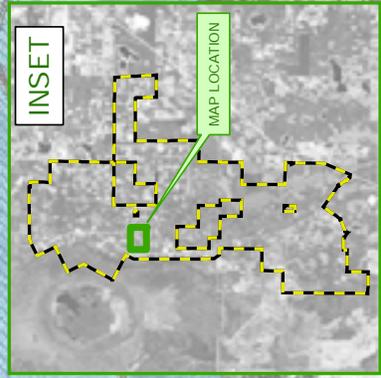
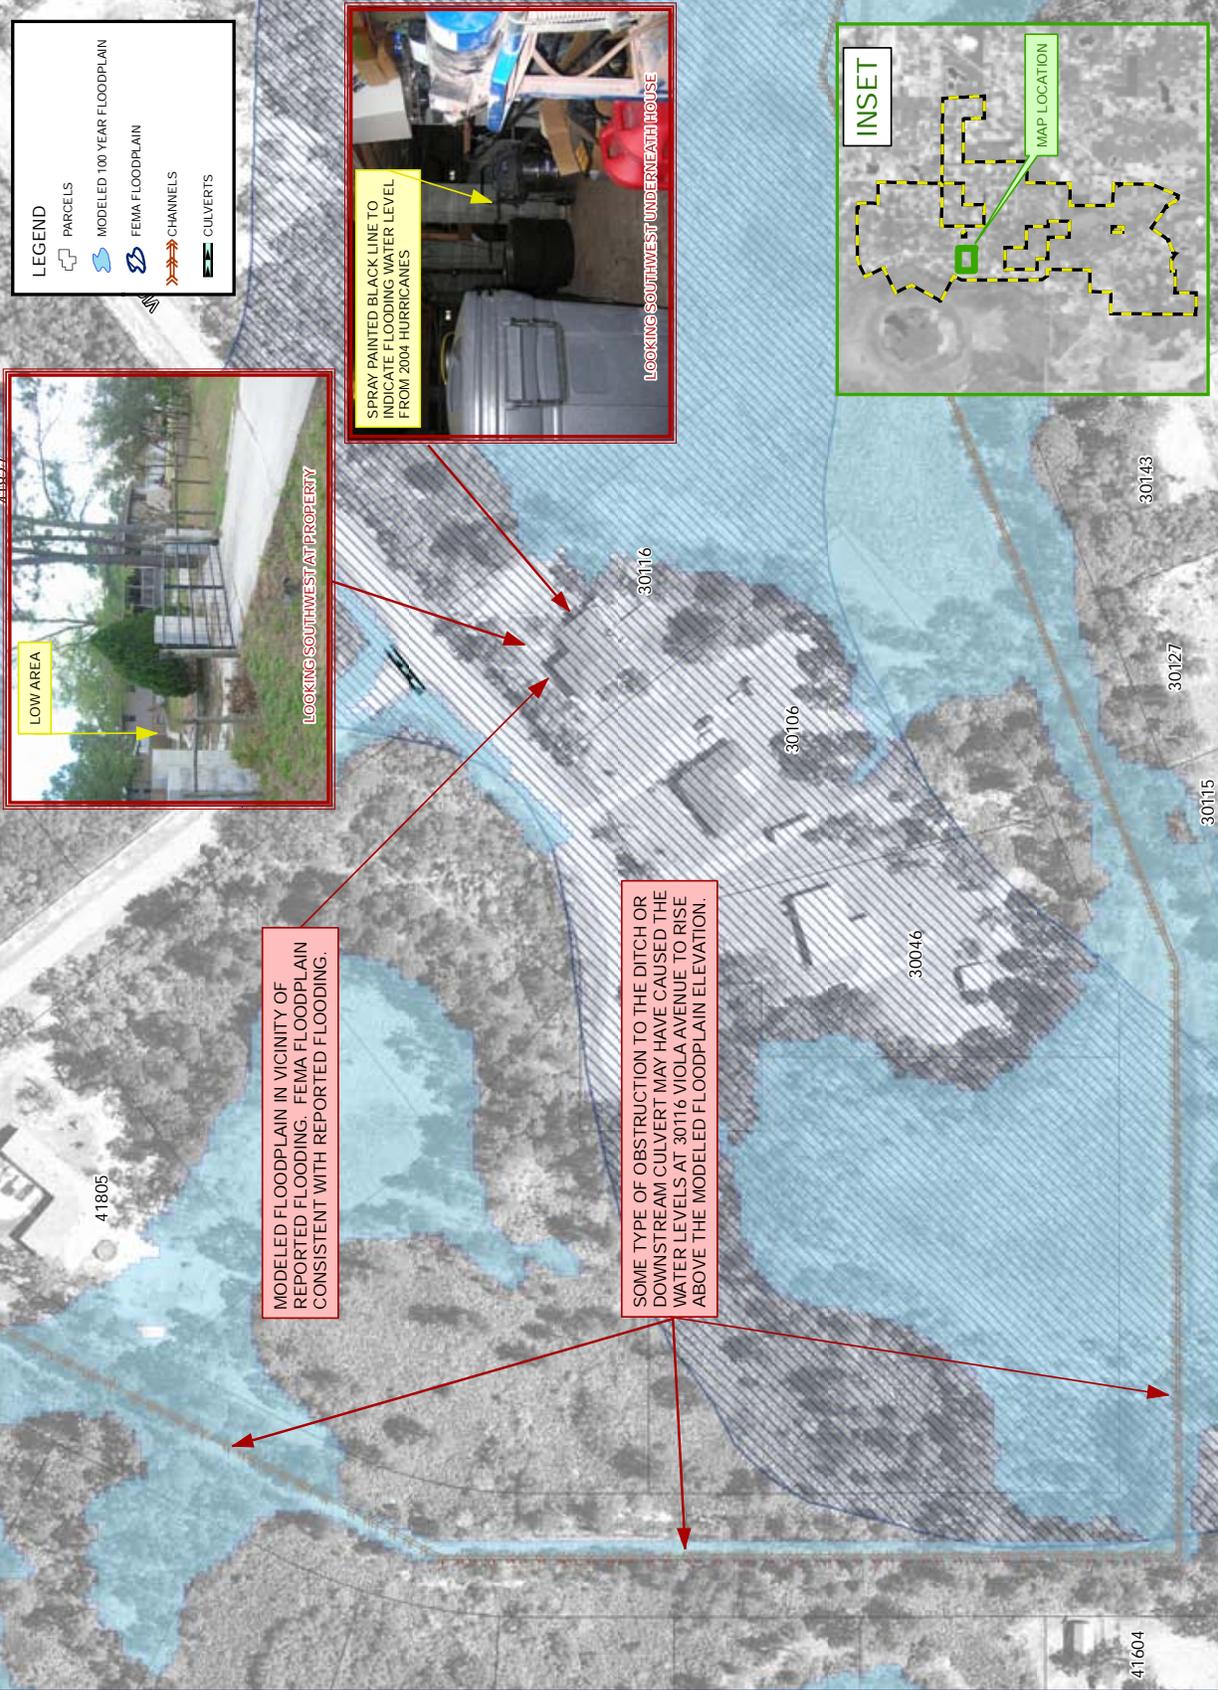
# FIGURE 8-3 30116 VIOLA AVENUE FLOOD SUMMARY MAP

MODELED FLOODPLAIN IN VICINITY OF REPORTED FLOODING. FEMA FLOODPLAIN CONSISTENT WITH REPORTED FLOODING.

SOME TYPE OF OBSTRUCTION TO THE DITCH OR DOWNSTREAM CULVERT MAY HAVE CAUSED THE WATER LEVELS AT 30116 VIOLA AVENUE TO RISE ABOVE THE MODELED FLOODPLAIN ELEVATION.
