LAKE COUNTY
FLORIDA

North Hancock Road Corridor Traffic Safety Study

May 22nd, 2012

**Presentation Prepared By
Lake County Public Works / Engineering Division
437 Ardice Avenue, Eustis FL**

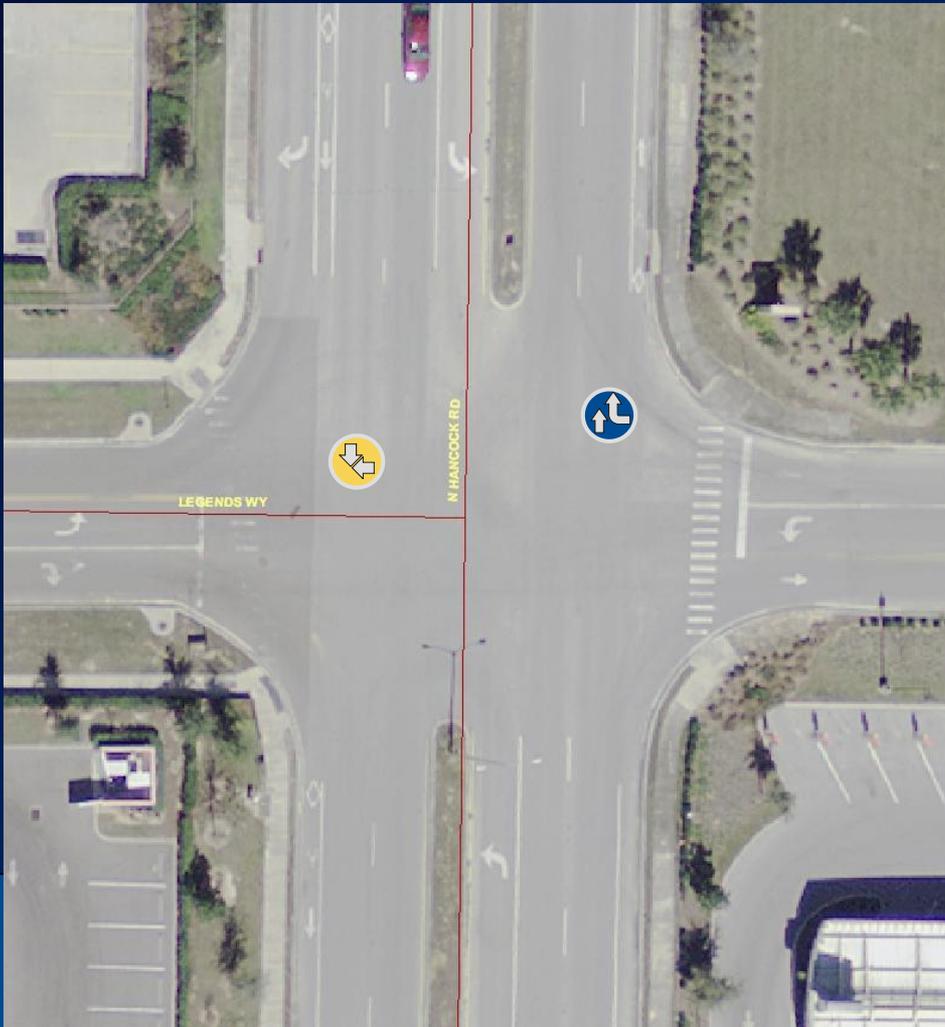
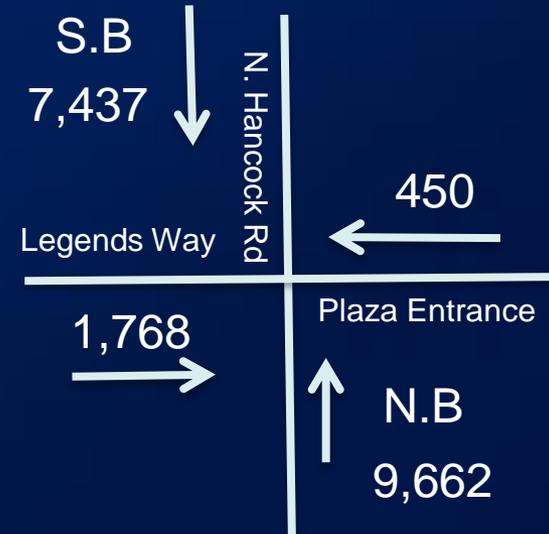
Legends Way Crash History

- ✓ 24 Hour Approach Count
- ✓ 4 Years Crash History
- ✓ 2 Crashes Reported

Crash at Intersection which can be corrected with signalization

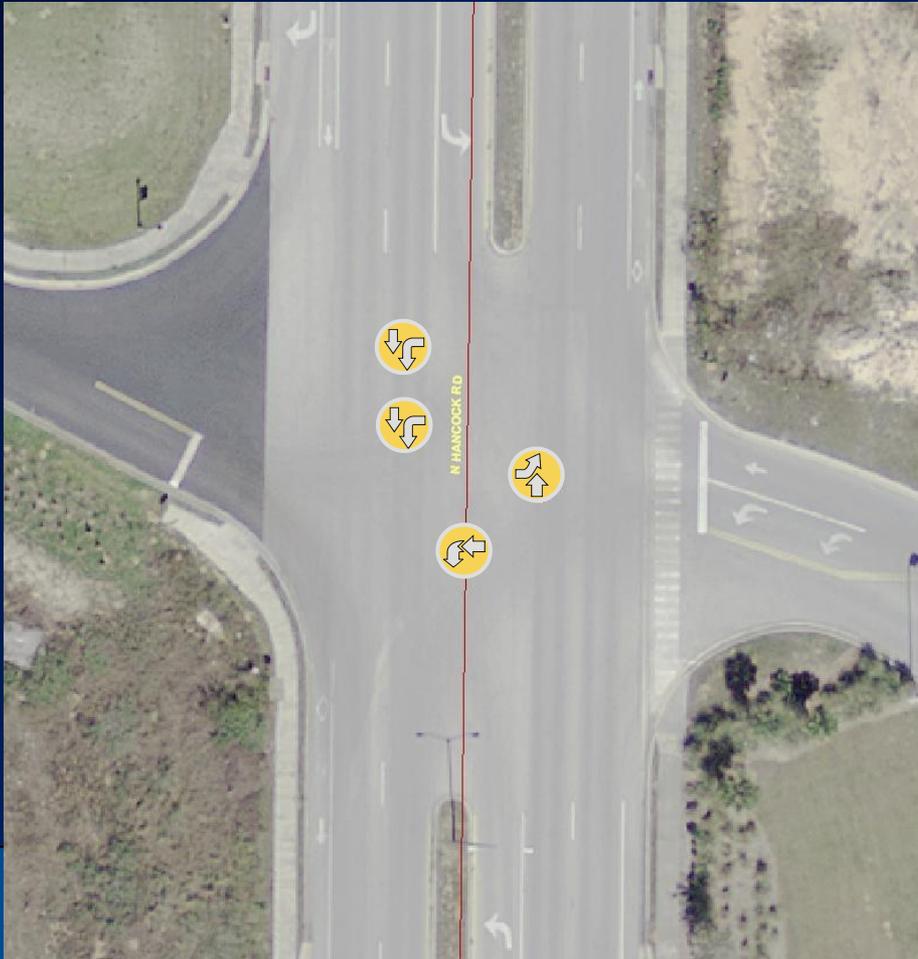
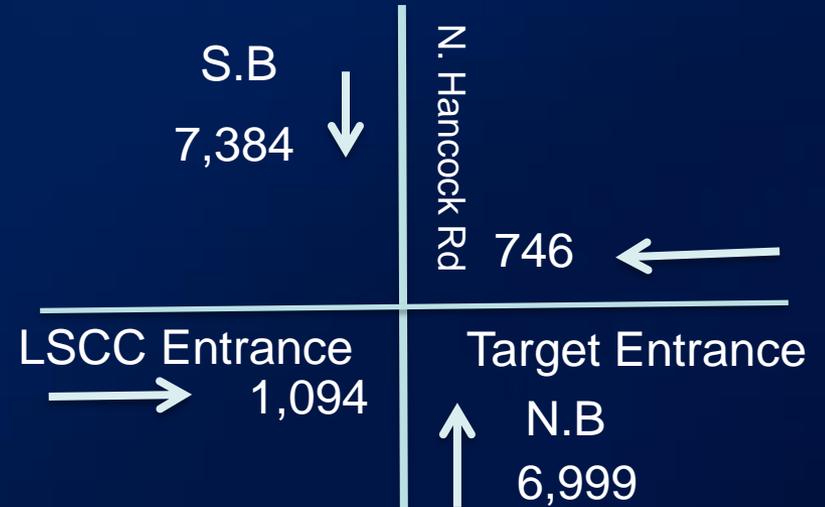
LSCC/Target Crash History

- ✓ 24 Hour Approach Count
- ✓ 4 Years Crash History
- ✓ 4 Crashes Reported

- Crash at Intersection
- Crash at Intersection which can be corrected with signalization

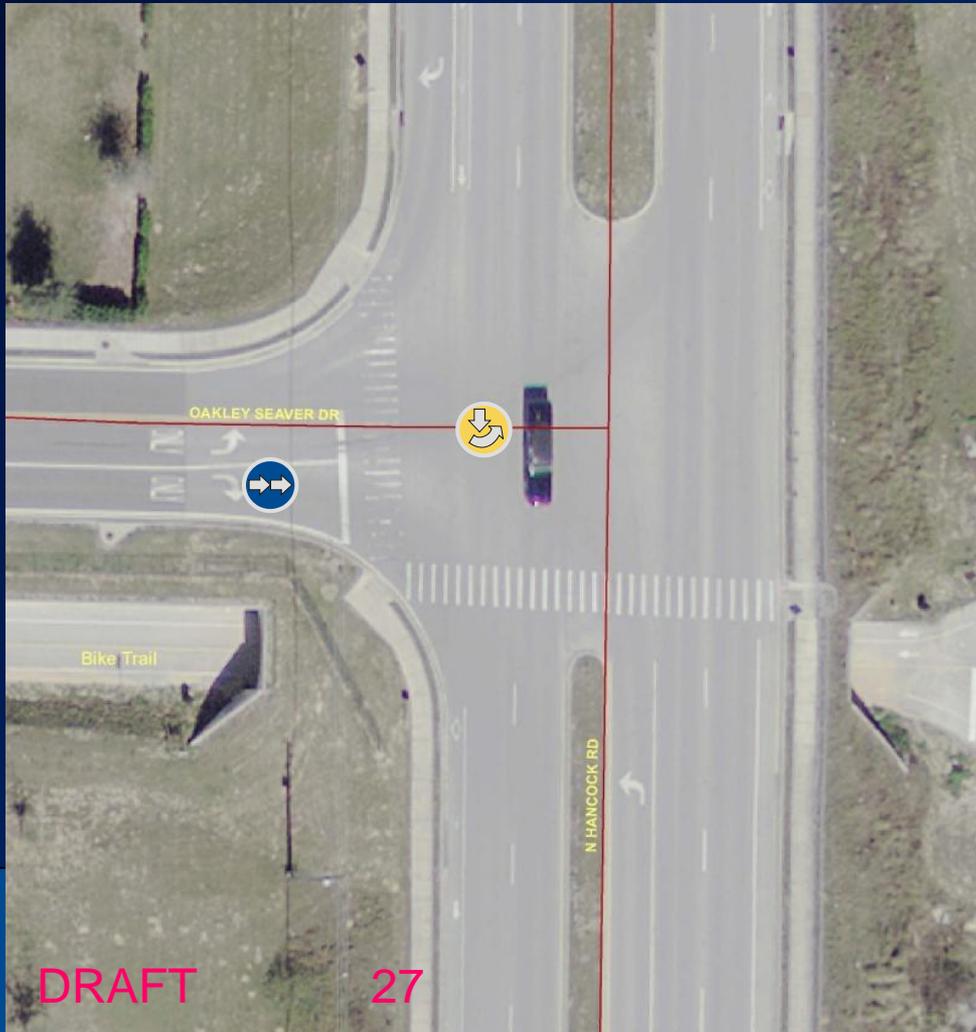
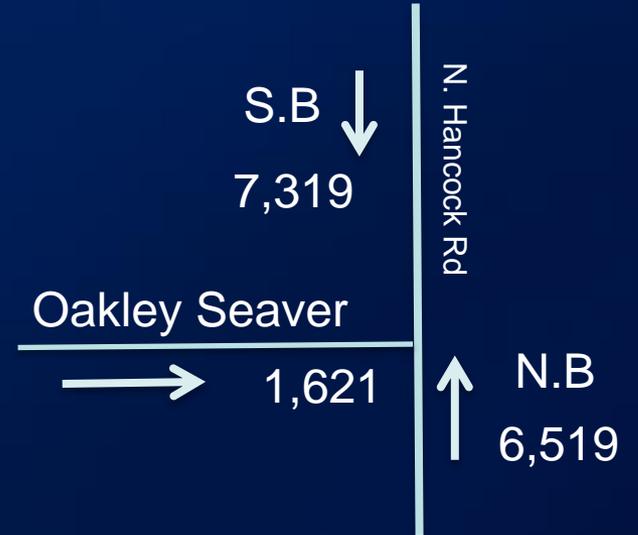
Oakley Seaver Drive Crash History

- ✓ 24 Hour Approach Count
- ✓ 4 Years Crash History
- ✓ 2 Crashes Reported

- Crash at Intersection
- Crash at Intersection which can be corrected with signalization

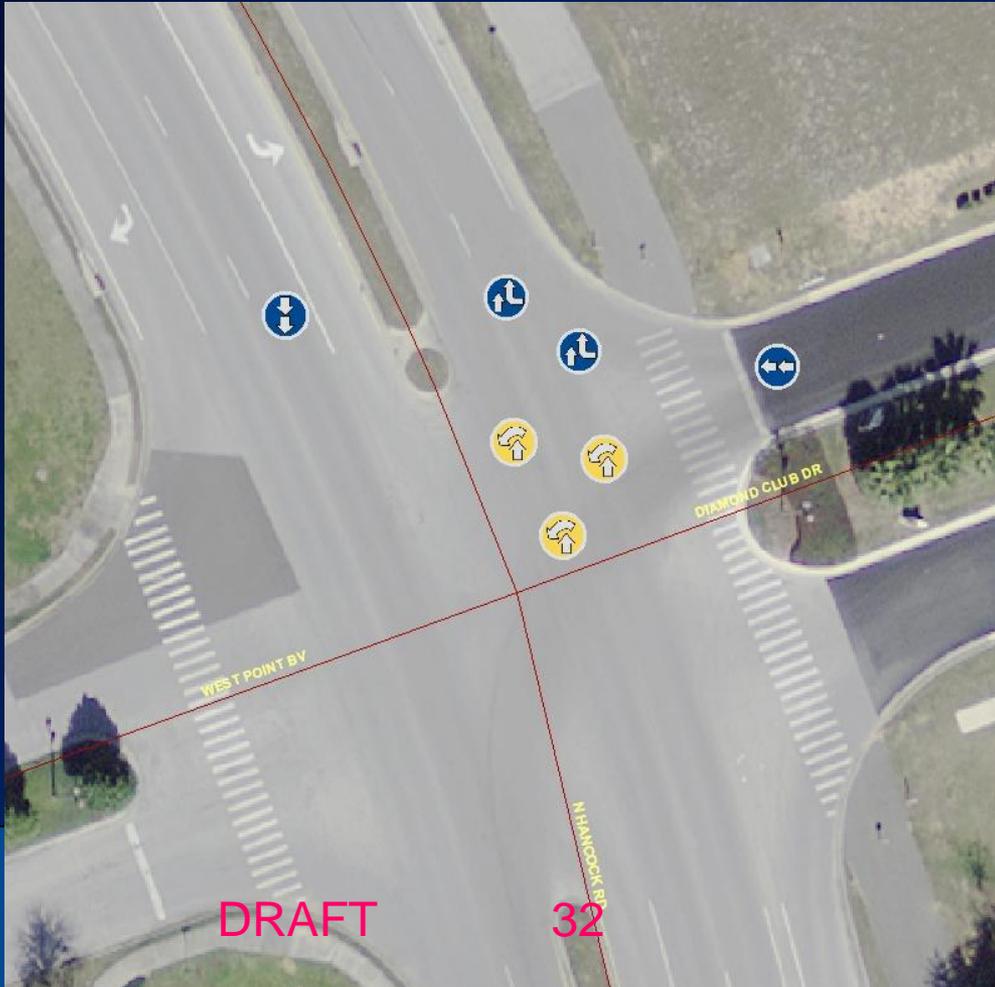
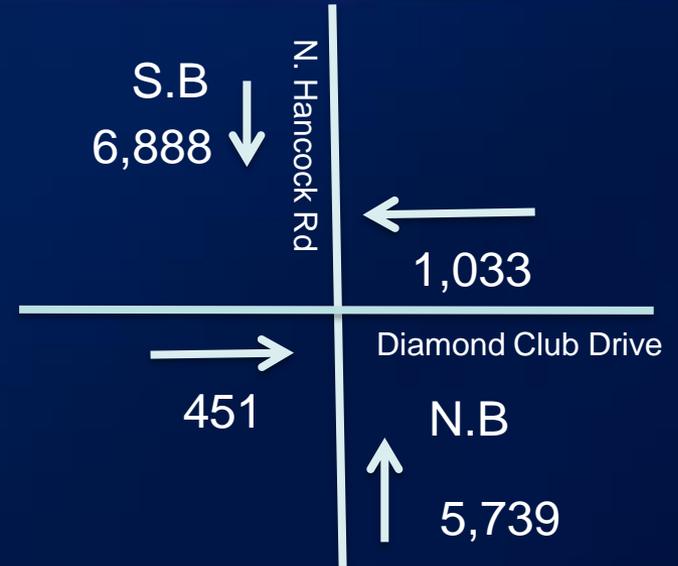
Diamond Club Dr. / West Point Blvd. Crash History

- ✓ 24 Hour Approach Count
- ✓ 4 Years Crash History
- ✓ 7 Crashes Reported

Crash at Intersection which can be corrected with signalization

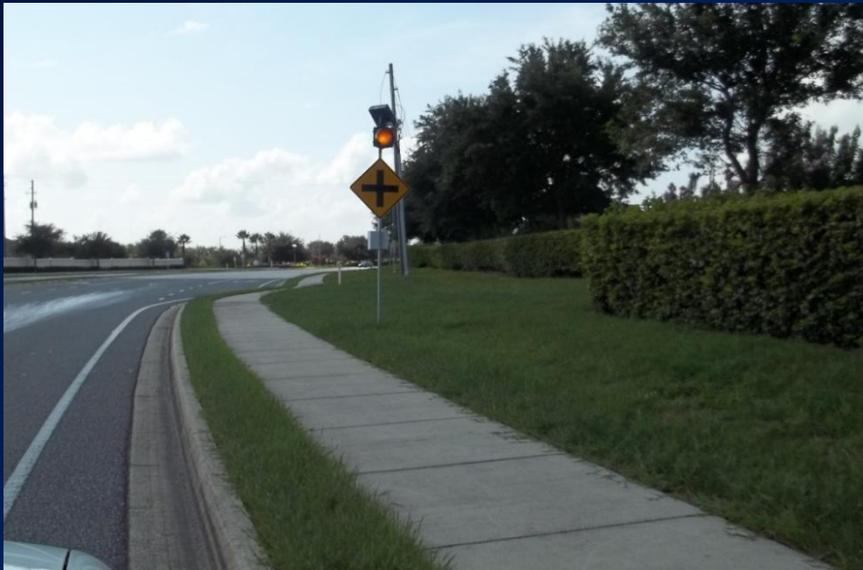
South Bound Approach

Intersection approach warning signs (W2-1) with flashing beacon

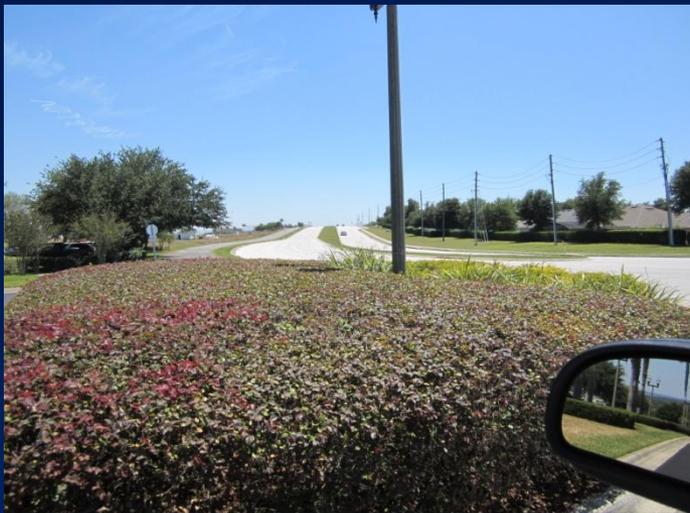
← Vehicles exiting Diamond Club Dr.
Note the line of sight (red)

Driver view at Diamond Club Dr.
(From van/truck window)

- Consider trimming vegetation at the front of the driveway to improve site distance
- Relocate Stop Bar on West Pt. Blvd
- Relocate Stop Bar on Diamond Club Drive.
- Re Stripe intersection and provide additional median guide stripes

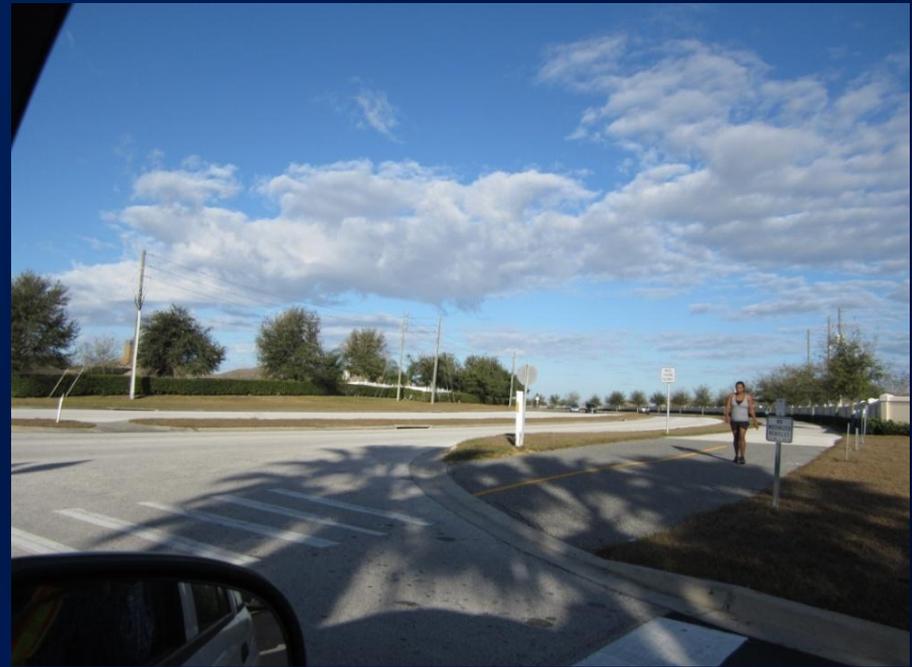
Passenger view at Diamond Club Dr.

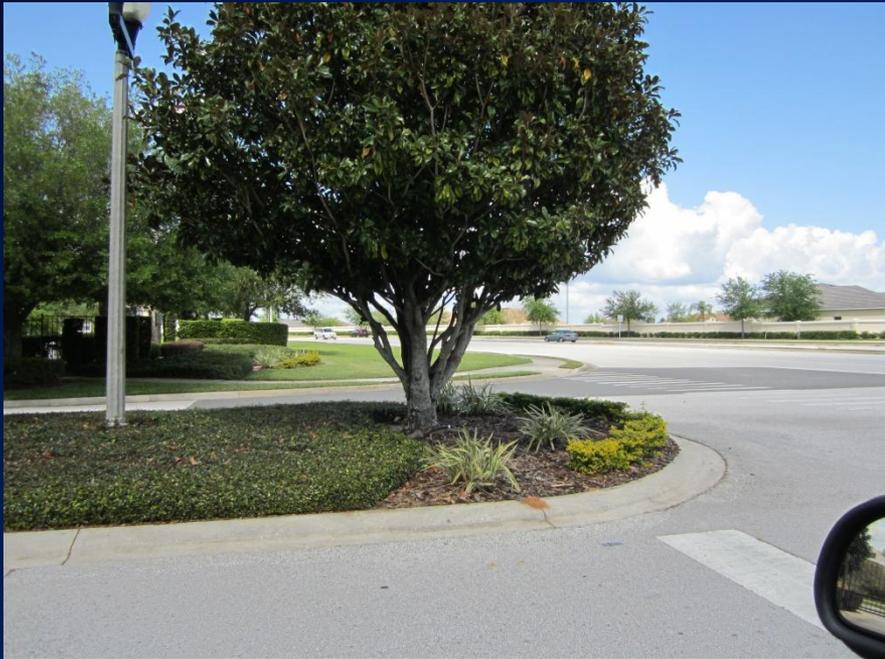
Driver view at West Point

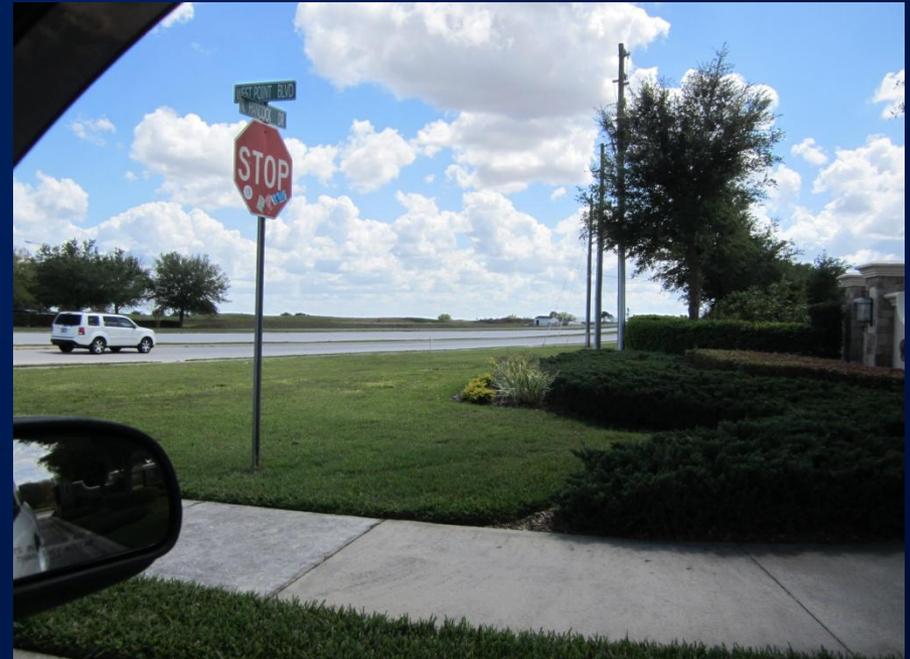
Passenger View at West Point

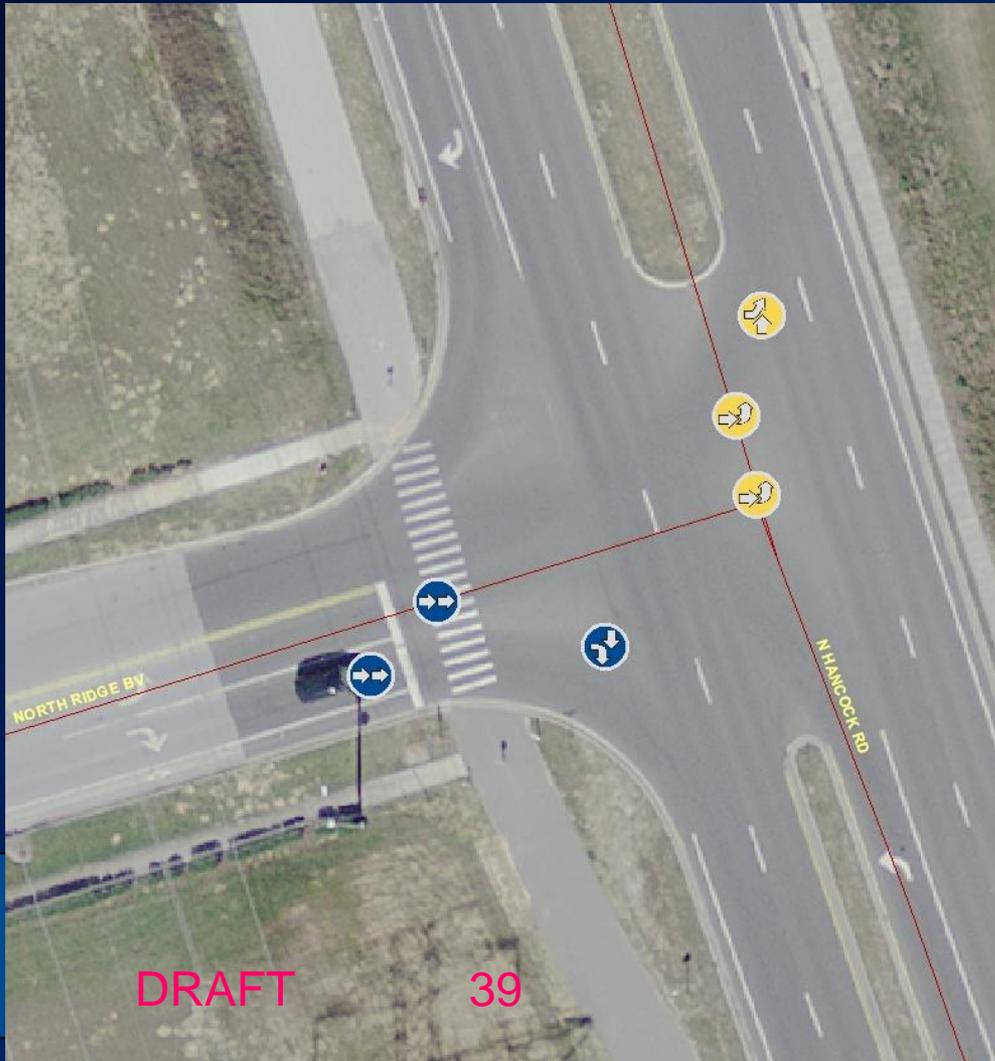
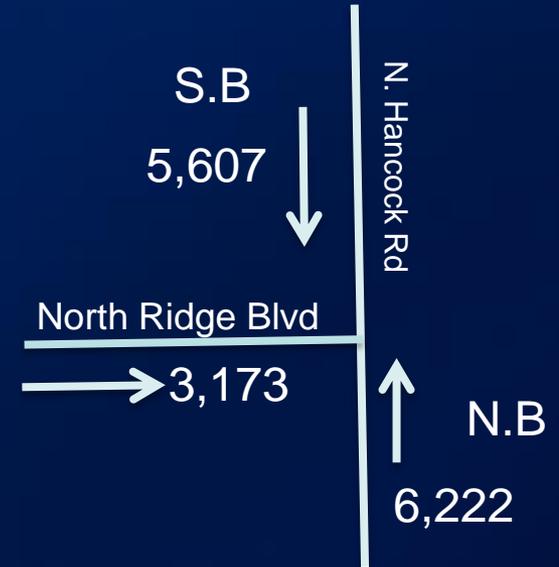
North Ridge Boulevard Crash History

- ✓ 24 Hour Approach Count
- ✓ 4 Years Crash History
- ✓ 6 Crashes Reported

- Crash at Intersection
- Crash at Intersection which can be corrected with signalization

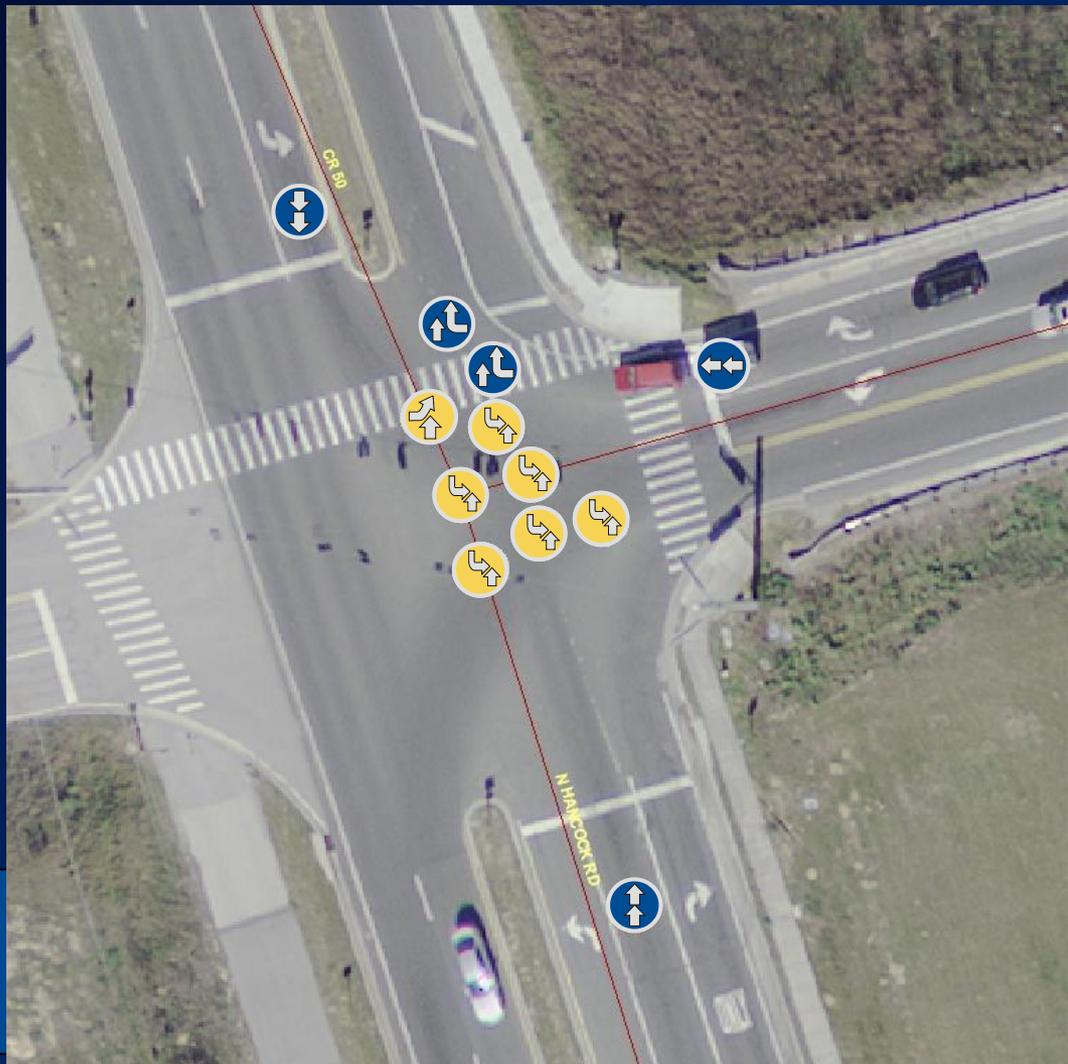
County Road 50 Crash History

- ✓ 24 Hour Approach Count
- ✓ 4 Years Crash History
- ✓ 12 Crashes Reported

- Crash at Intersection
- Crash at Intersection which can be corrected with signalization

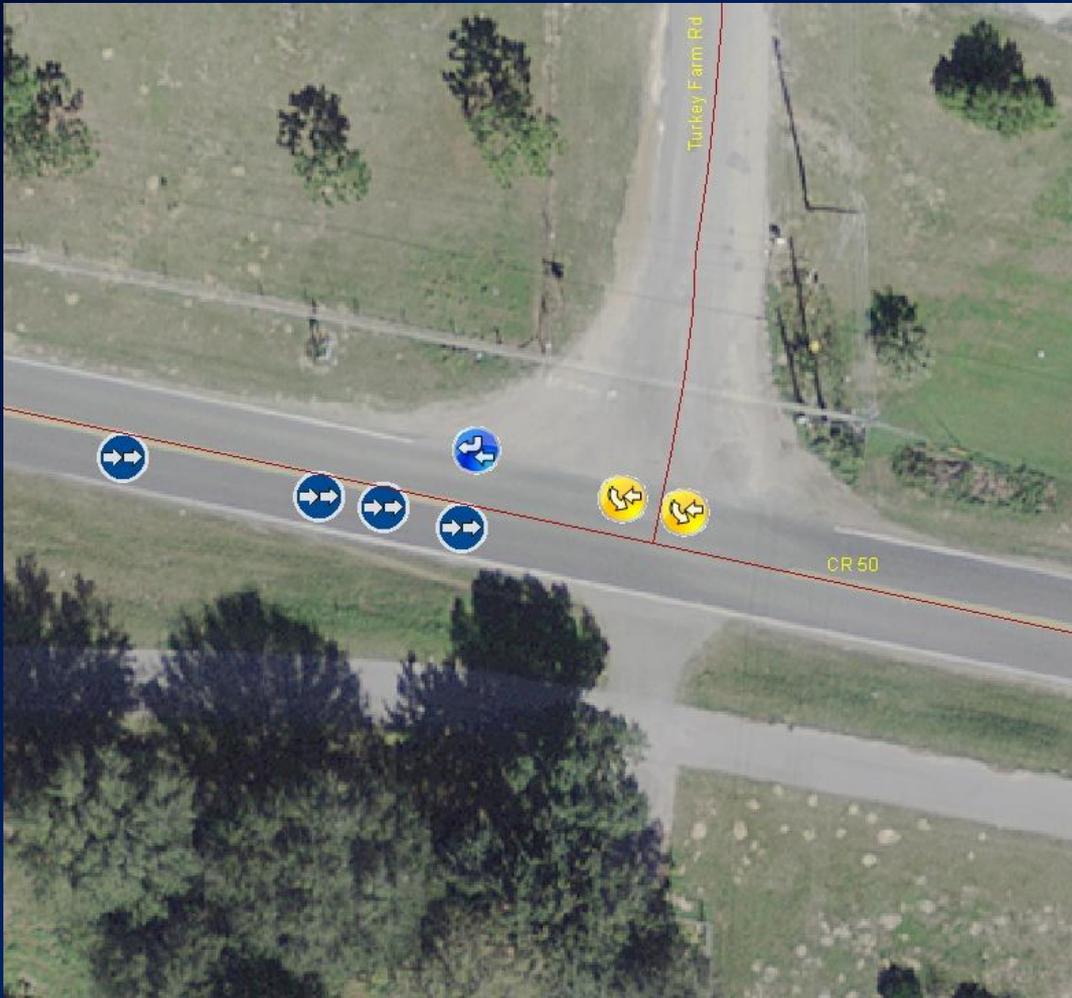
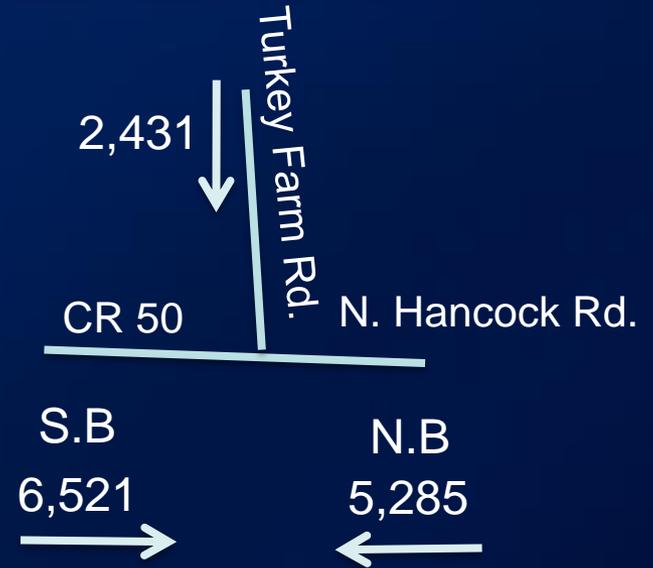
CR 50 and Turkey Farm Rd Crash History

- ✓ 24 Hour Approach Count
- ✓ 4 Years Crash History
- ✓ 7 Crashes Reported
