### ADDENDUM #3

CR 466A Phase I (US Highway 27/441 to Sunny Court)  
Project No. 2016-02  
Bid No. 16-0017

# NESHAP ASBESTOS DEMOLITION SURVEY REPORT

## CR-466A Abandoned Greenhouse

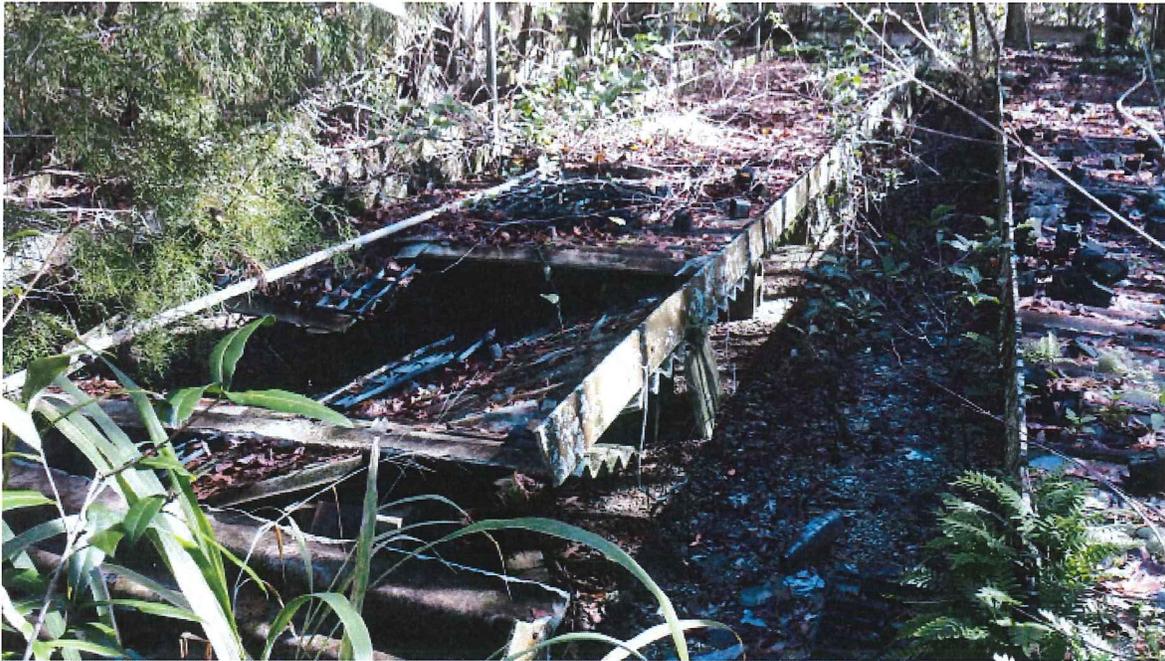
Nine (9) of the ten (10) samples collected for analysis by PLM had detected asbestos mineral fibers (more than 1%) and are considered ACM. These included the cement boards used for the table tops and the exterior siding panels of the greenhouse. *Many of the boards have been damaged, broken and rest on the floor of the greenhouse or the exterior ground surrounding the structure. Some exterior panels seem to have been removed from the site. The boards are damaged; however the materials are still assessed to be a Category II non friable ACM.*

Homogeneous Area 01 – Gray Corrugated-Board Table-tops

*Due to the nature of the damage to the materials Tierra recommends a Florida Licensed asbestos contractor be used to demolish the building. Care should be taken to minimize additional breakage of the cement boards while employing wet demolition practices to prevent asbestos fibers from being released.*

*The removed material should be disposed of at a properly licensed landfill that is certified to receive asbestos containing material (ACM).*

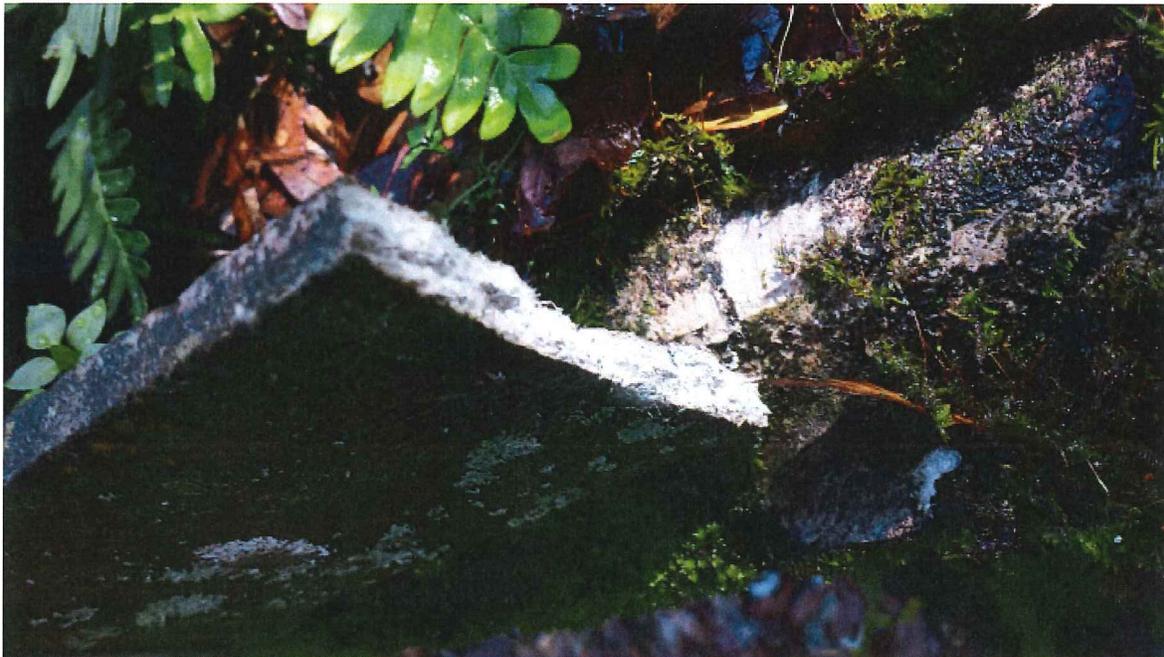
Homogeneous Area 02 – Gray 1"x4" Table-top Sides

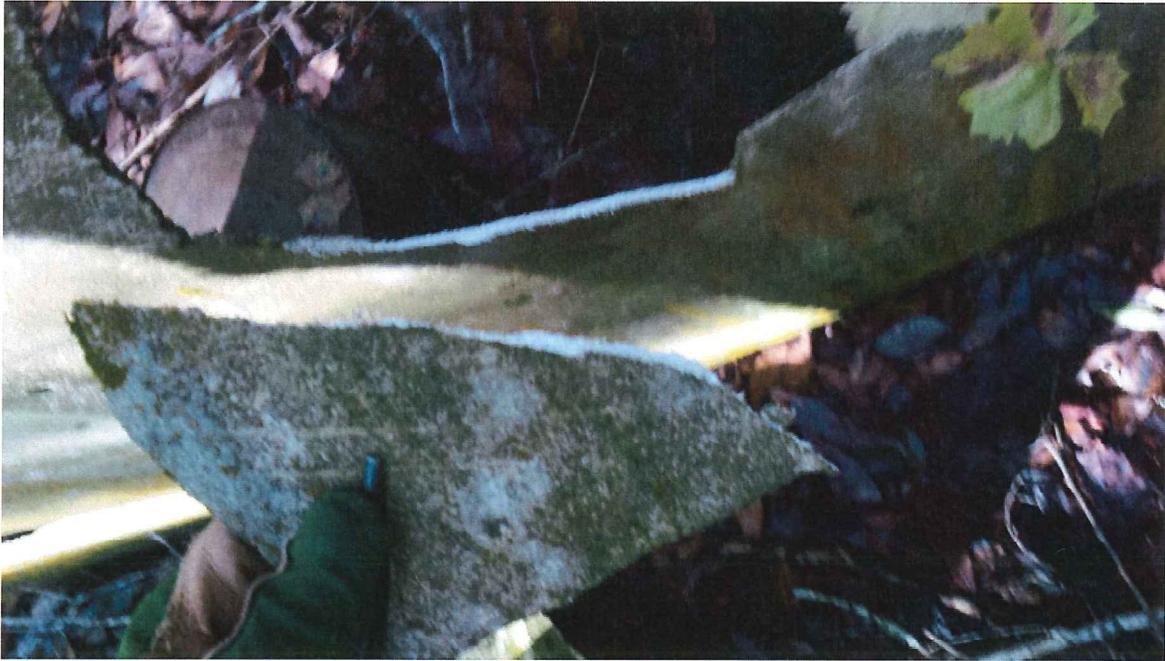
Homogeneous Area 03 – Gray Wall Panel Boards, Lower Exterior Walls

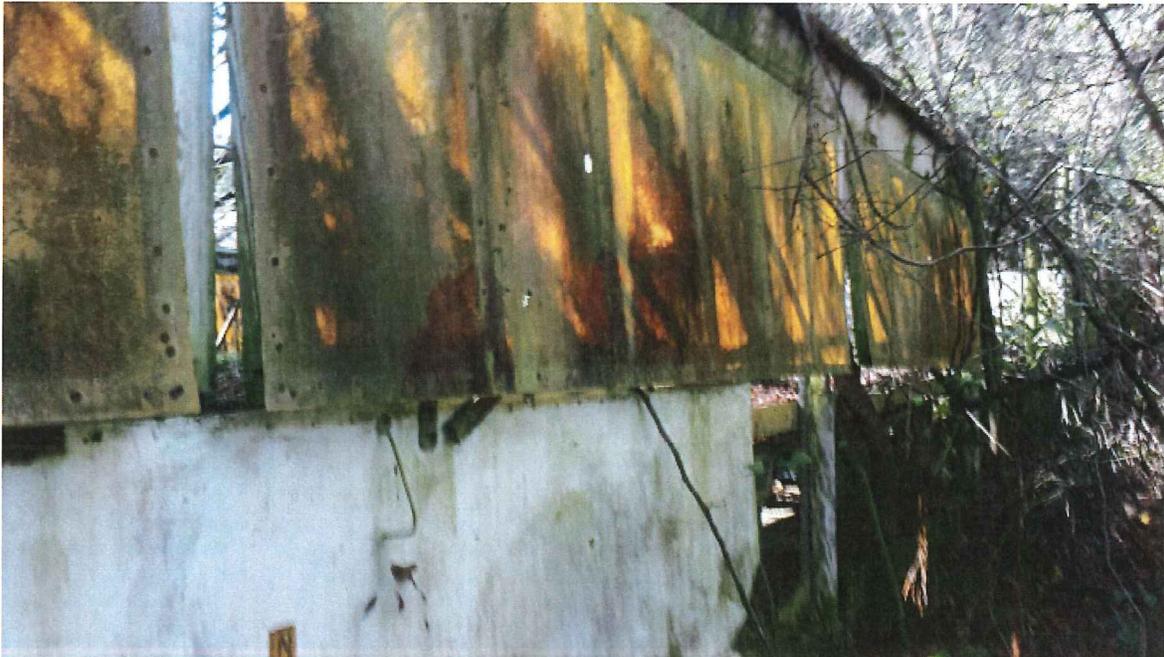
Homogeneous Area 04 – Fiberglass Wall Panels, Upper Exterior Walls
