Preliminary Flood Assessment  
Technical Memorandum  
**Royal Trails Flood Study**

**LAKE COUNTY**  
FLORIDA

**Re: Royal Trails Flood Study  
Preliminary Flood Assessment Technical Memorandum  
County PO # 20701804**

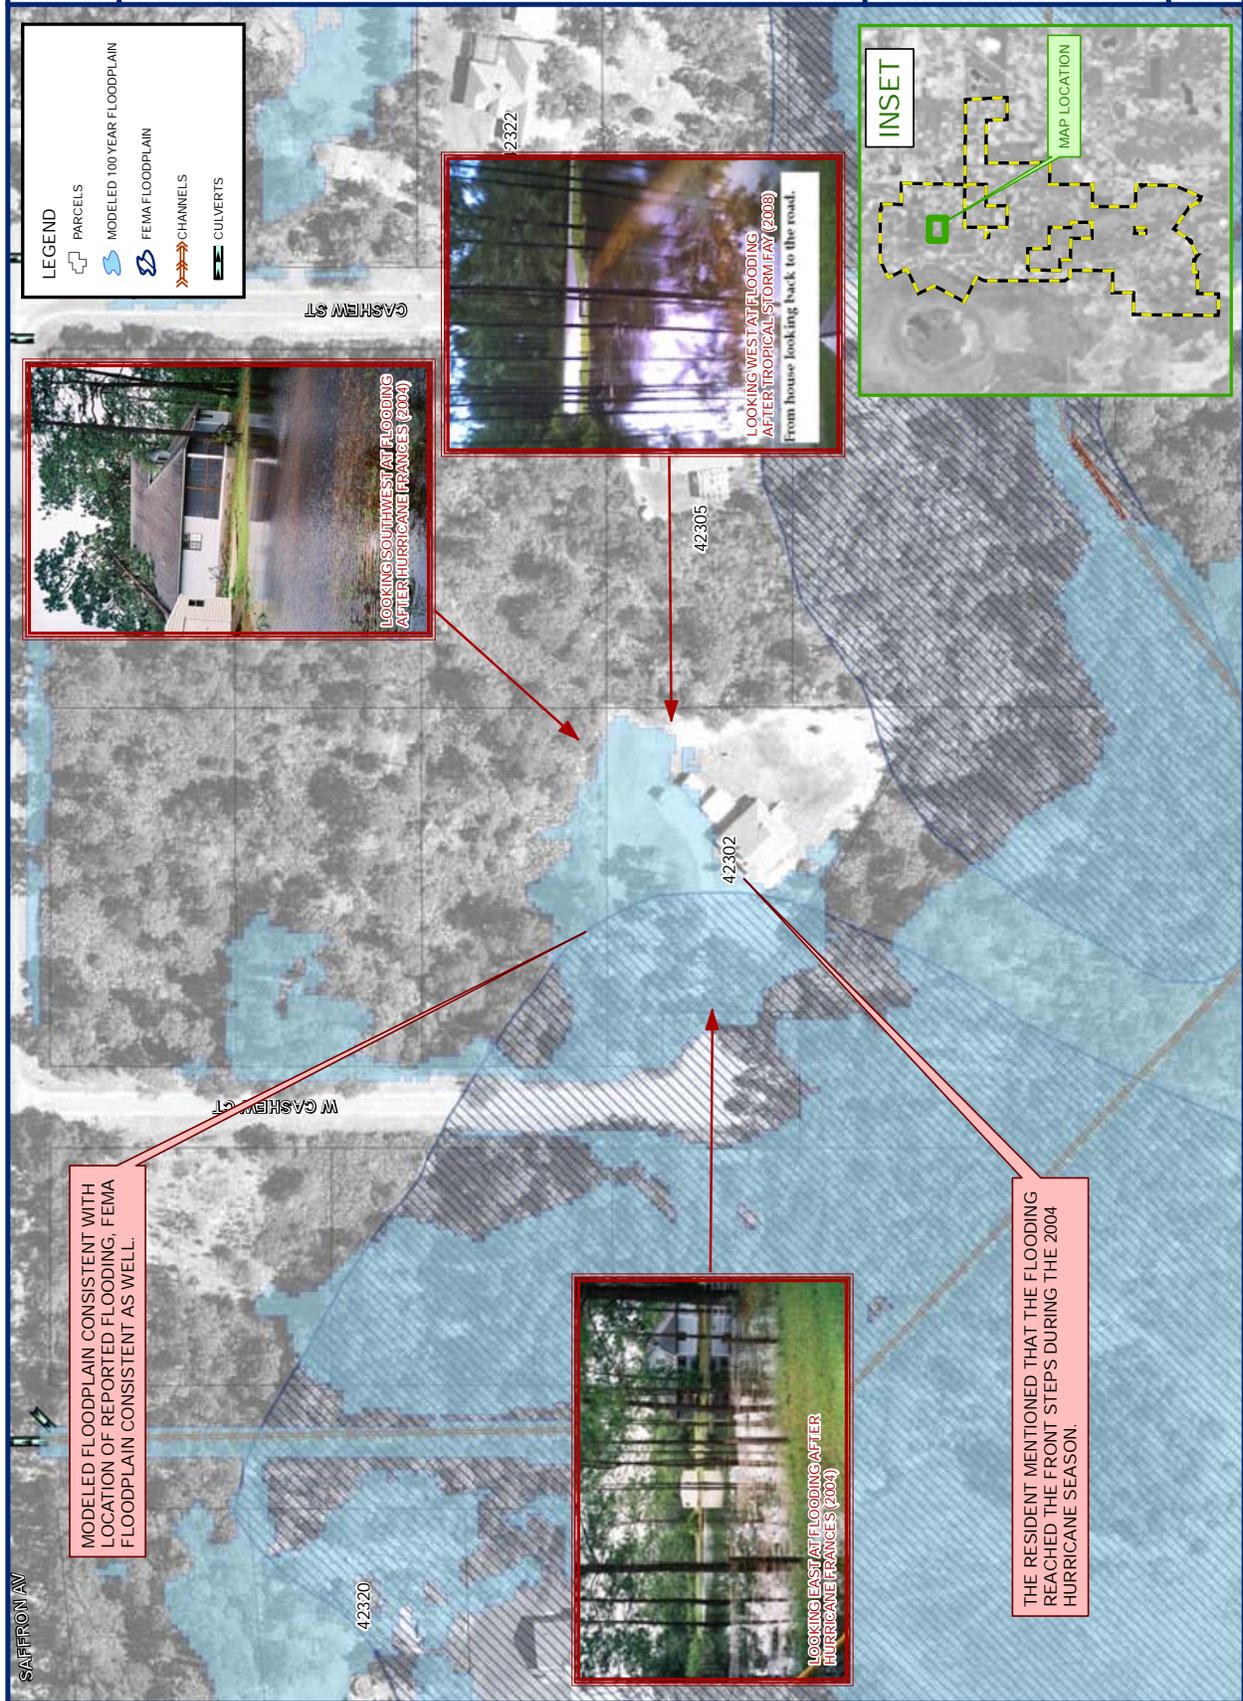
THE RESIDENT MENTIONED THAT THE FLOODING REACHED THE FRONT STEPS DURING THE 2004 HURRICANE SEASON.

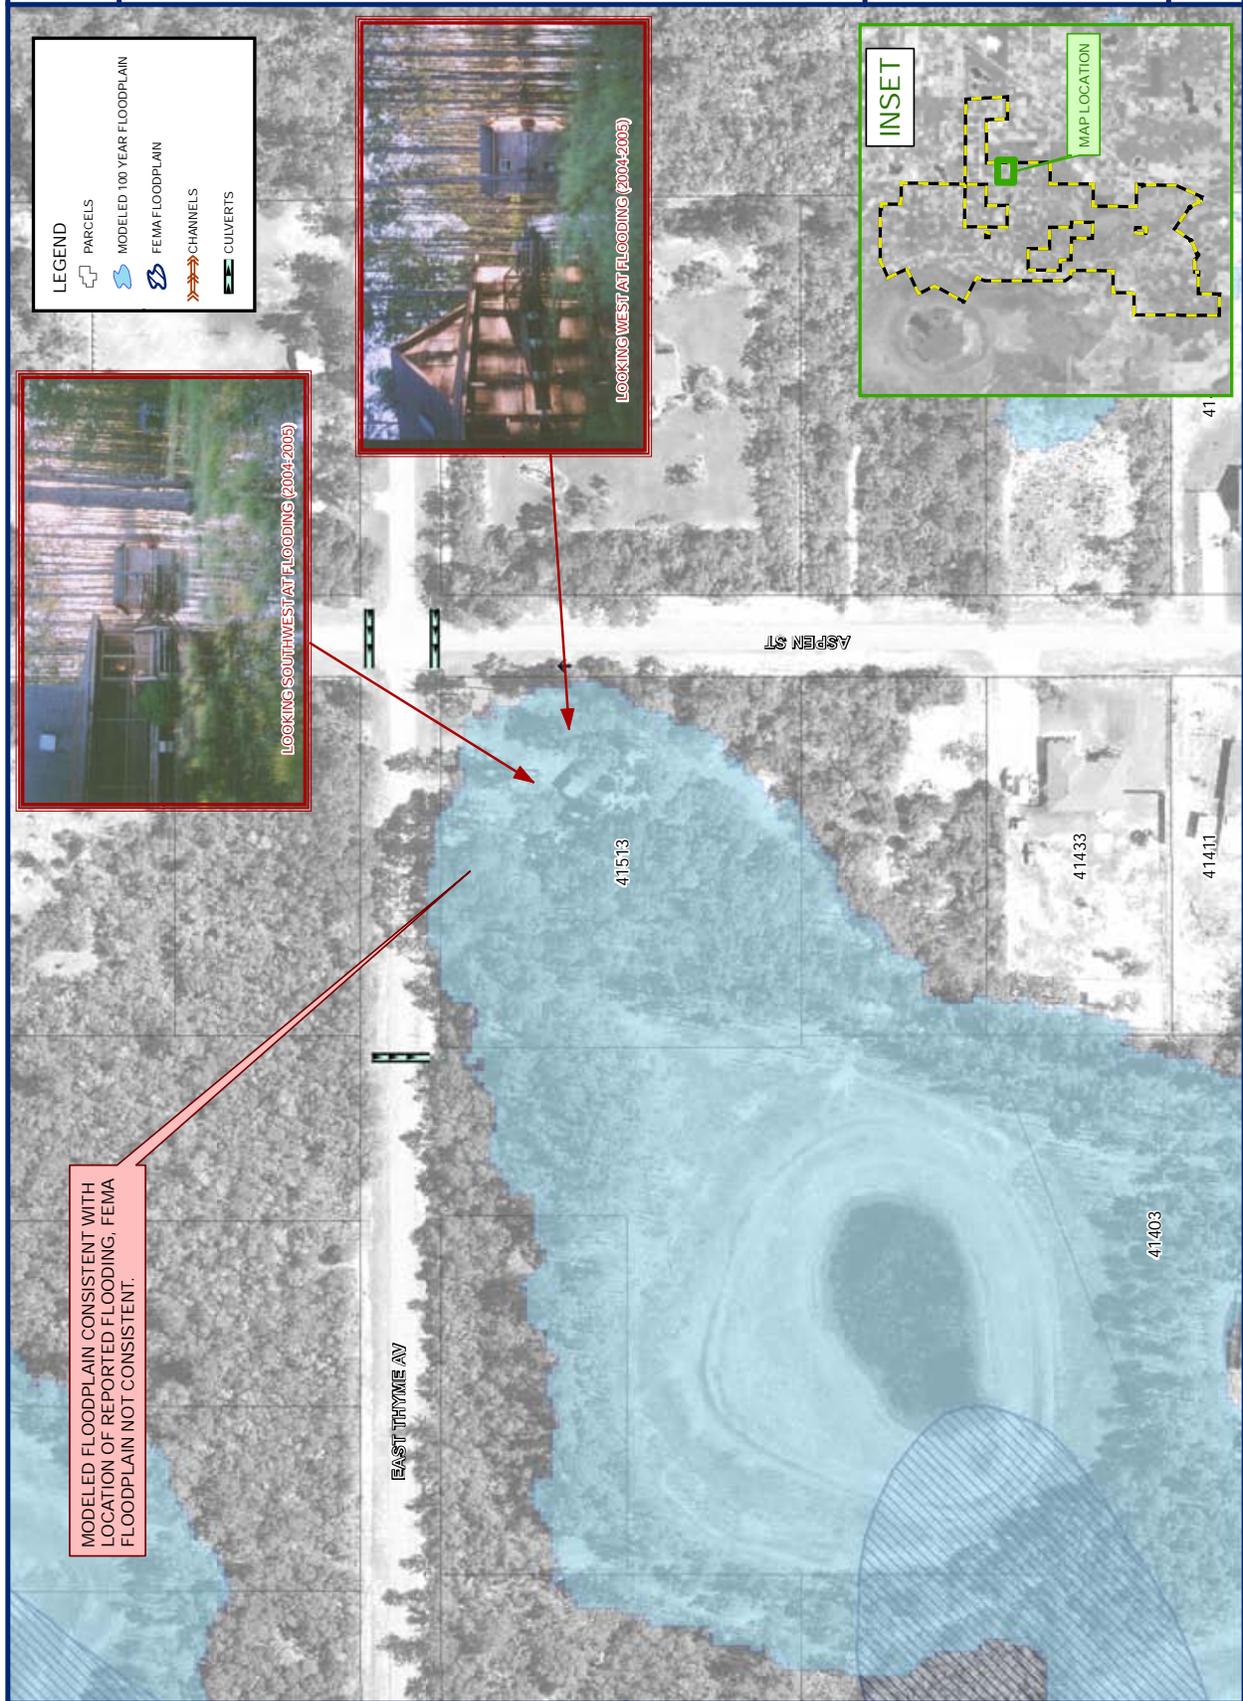
MODELED FLOODPLAIN CONSISTENT WITH LOCATION OF REPORTED FLOODING, FEMA FLOODPLAIN NOT CONSISTENT.

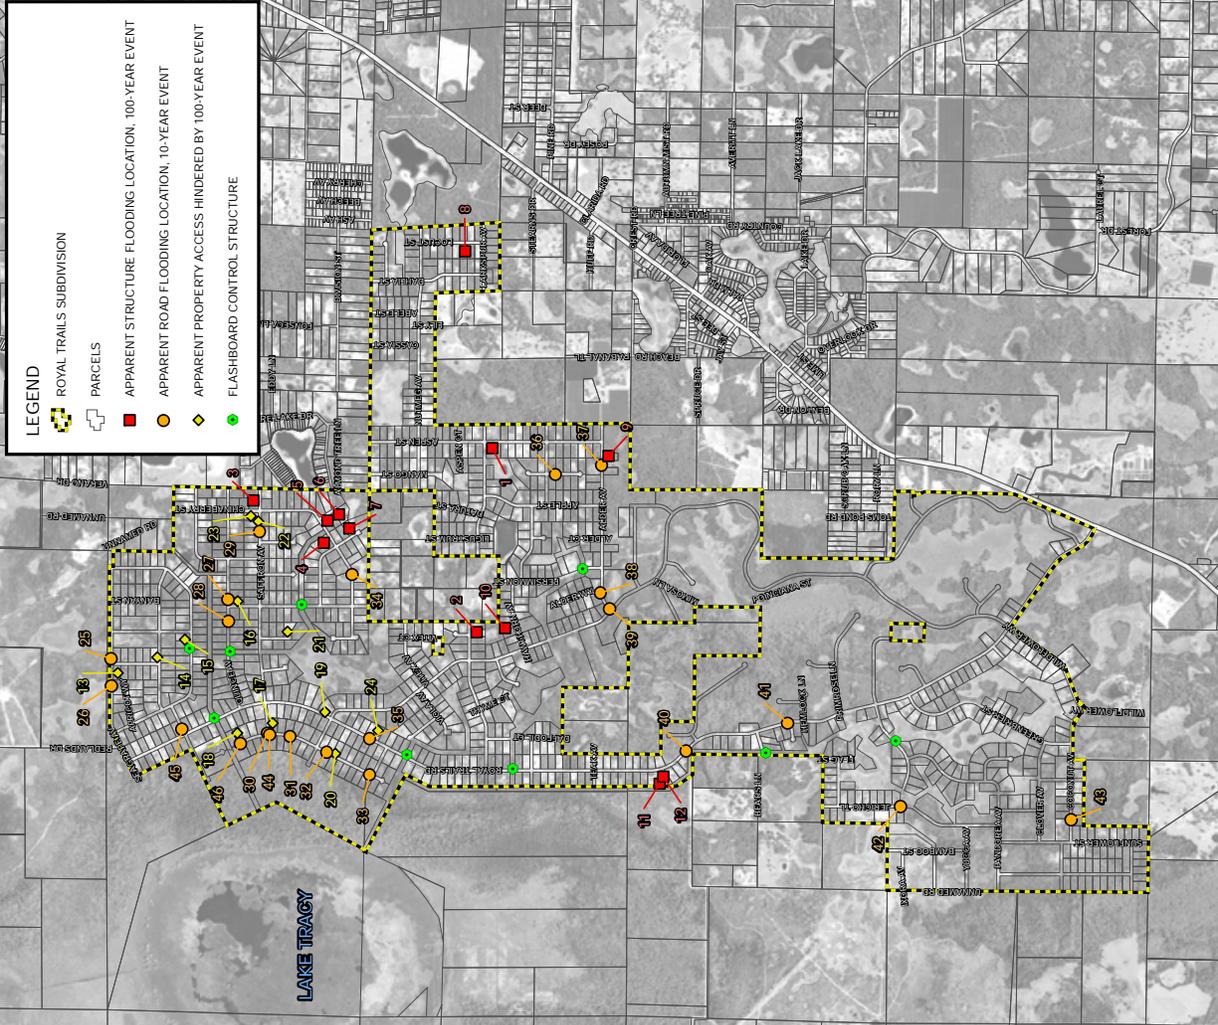
APPARENT FLOOD IMPACT SUMMARY	
HOUSES IMPACTED BY 100-YEAR STORM EVENT	
ID #	ADDRESS
1	41513 ASPEN ST
2	30428 WEST THYME ST
3	30911 SAFFRON AVE
4	42141 CHINABERRY ST
5	42133 CHINABERRY CT
6	42111 CHINABERRY CT
7	30839 KUMOUAT AVE
8	41631 LOCUST ST
9	31110 ALDER AVE
10	30451 HAWTHORN ST
11	40901 ROYAL TRAILS RD
12	40835 ROYAL TRAILS RD
YARDS IMPACTED BY 100-YEAR STORM EVENT	
ID #	ADDRESS
13	42943 HONEYSUCKLE ST
14	42810 HONEYSUCKLE ST
15	30411 APRICOT AVE
16	30554 QUINCE AVE
17	42330 TAMARAC ST
18	42454 TAMARACK WAY
19	42122 POINCIANA ST
20	42106 SOUTH TAMARAC ST
21	42302 WEST CASHAW CT
22	30849 SAFFRON AVE
23	30901 SAFFRON AVE
24	41942 ROYAL TRAILS RD
ROAD OVERTOPPING DURING 10-YEAR STORM EVENT	
ID #	ROAD NAME
25	SEAGRAPE AV
26	SEAGRAPE AV
27	QUINCE AV
28	QUINCE AV
29	SAFFRON AV
30	SAFFRON AV
31	TAMARAC ST
32	TAMARAC ST
33	TAMARAC ST
34	CHINABERRY ST
35	ROYAL TRAILS RD
36	BALSAM ST
37	ALDER AV
38	ALDER AV
39	ALDER AV
40	ROYAL TRAILS RD

41	ROYAL TRAILS RD
42	JERICHO TL
43	COCONUT AV
44	TAMARAC ST
45	CINNAMON AV
46	TAMARAC ST

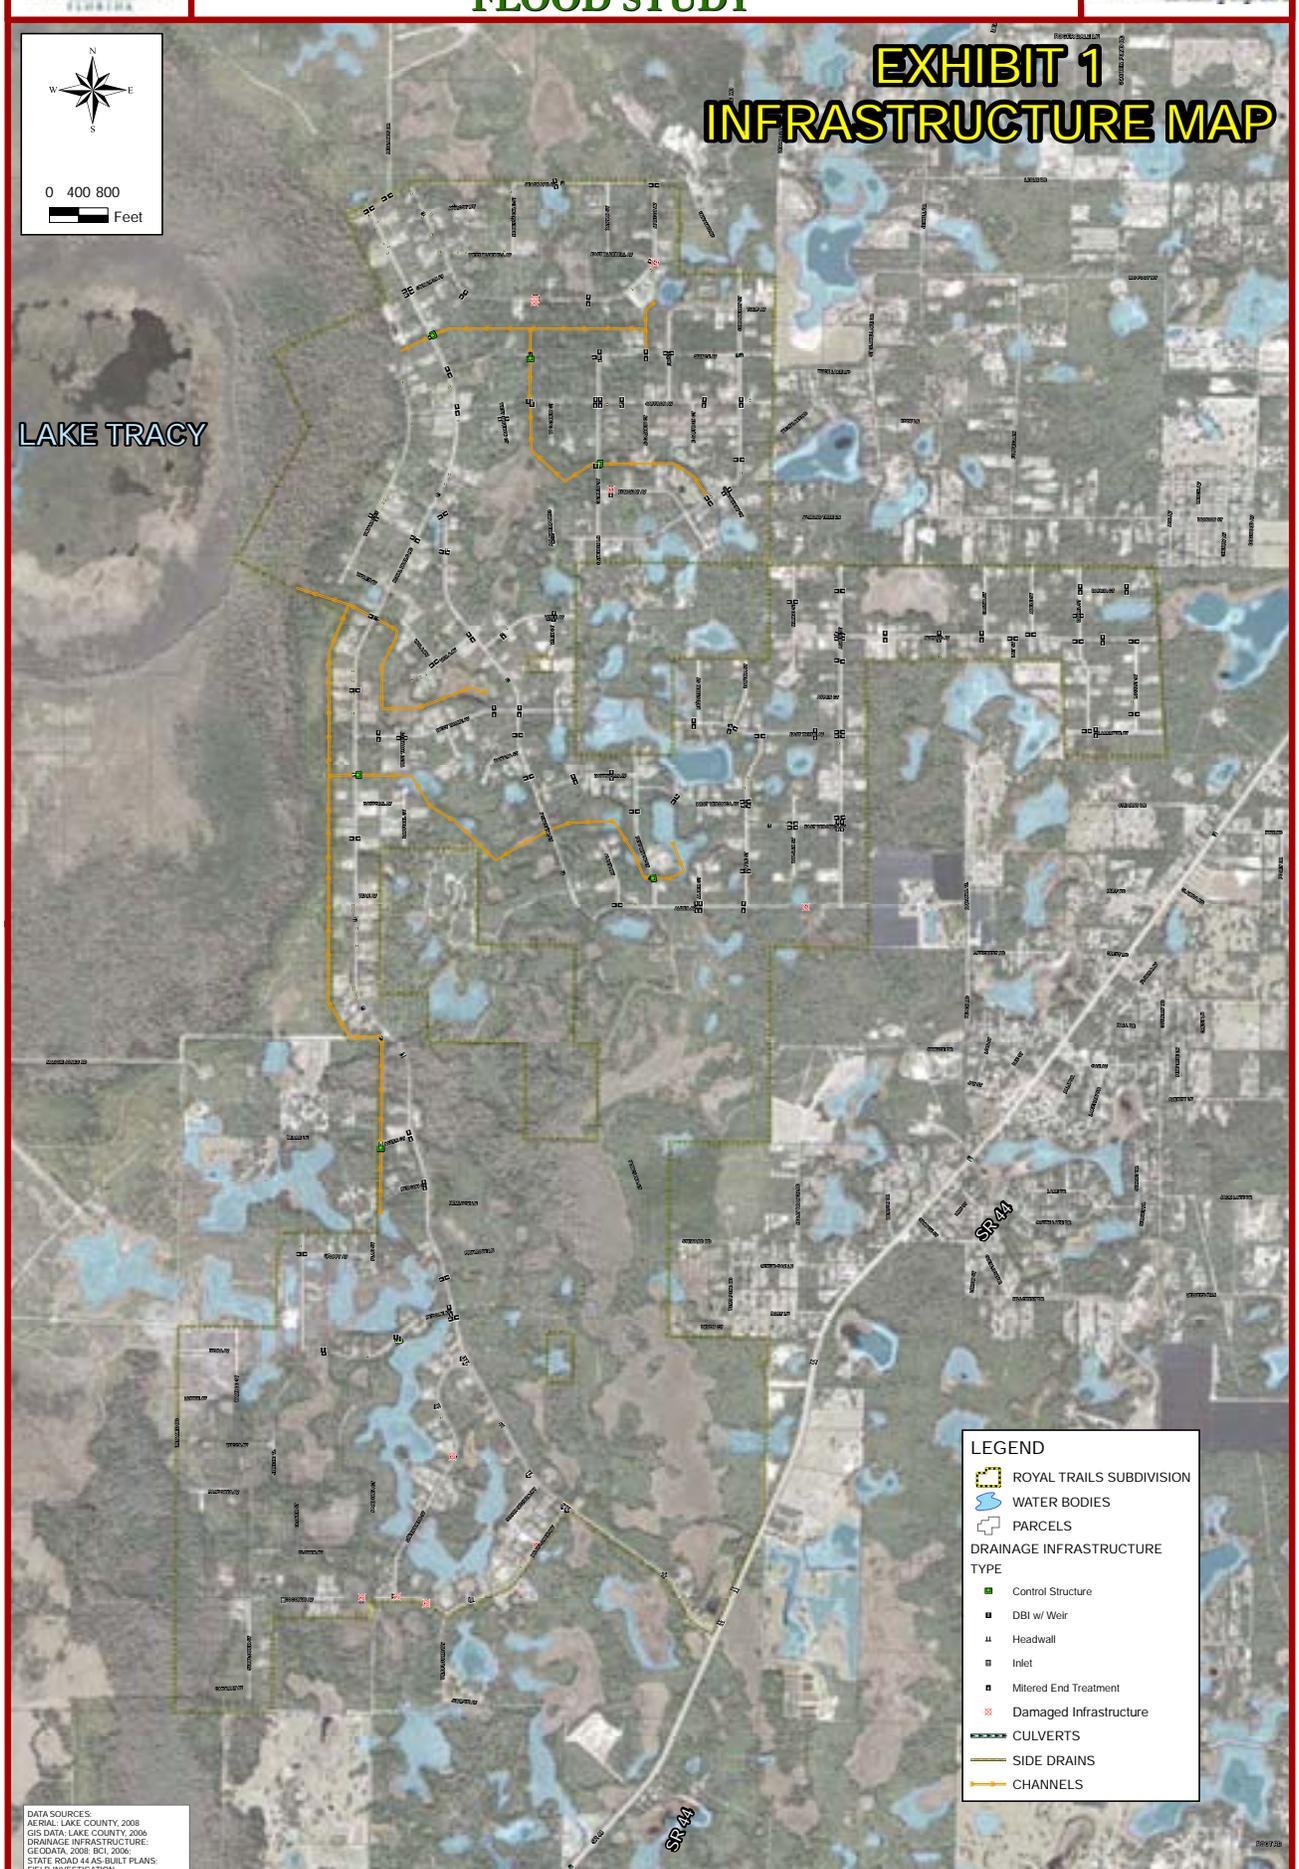
## EXHIBIT 1 INFRASTRUCTURE MAP

DATA SOURCES:  
AERIAL: LAKE COUNTY, 2008  
GIS DATA: LAKE COUNTY, 2008  
DRAINAGE INFRASTRUCTURE:  
GEO DATA, 2008; BCL, 2006  
STATE ROAD 44 AS-BUILT PLANS:  
FIELD INVESTIGATION  
DAMAGED INFRASTRUCTURE: BCL 2006  
REPRESENTS CRUSHED PIPE ENDS  
AND/OR DAMAGED END TREATMENT
