LAKE COUNTY
FLORIDA

North Hancock Road Corridor Traffic Safety Study

May 22nd, 2012

**Presentation Prepared By
Lake County Public Works / Engineering Division
437 Ardice Avenue, Eustis FL**

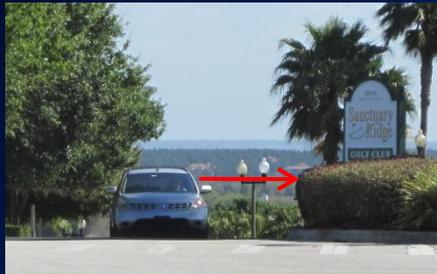
Diamond Club Drive Sight Distance

← Vehicles exiting Diamond Club Dr.
Note the line of sight (red)

- Consider trimming vegetation at the front of the driveway to improve site distance
- Relocate Stop Bar on West Pt. Blvd
- Relocate Stop Bar on Diamond Club Drive.
- Re Stripe intersection and provide additional median guide stripes

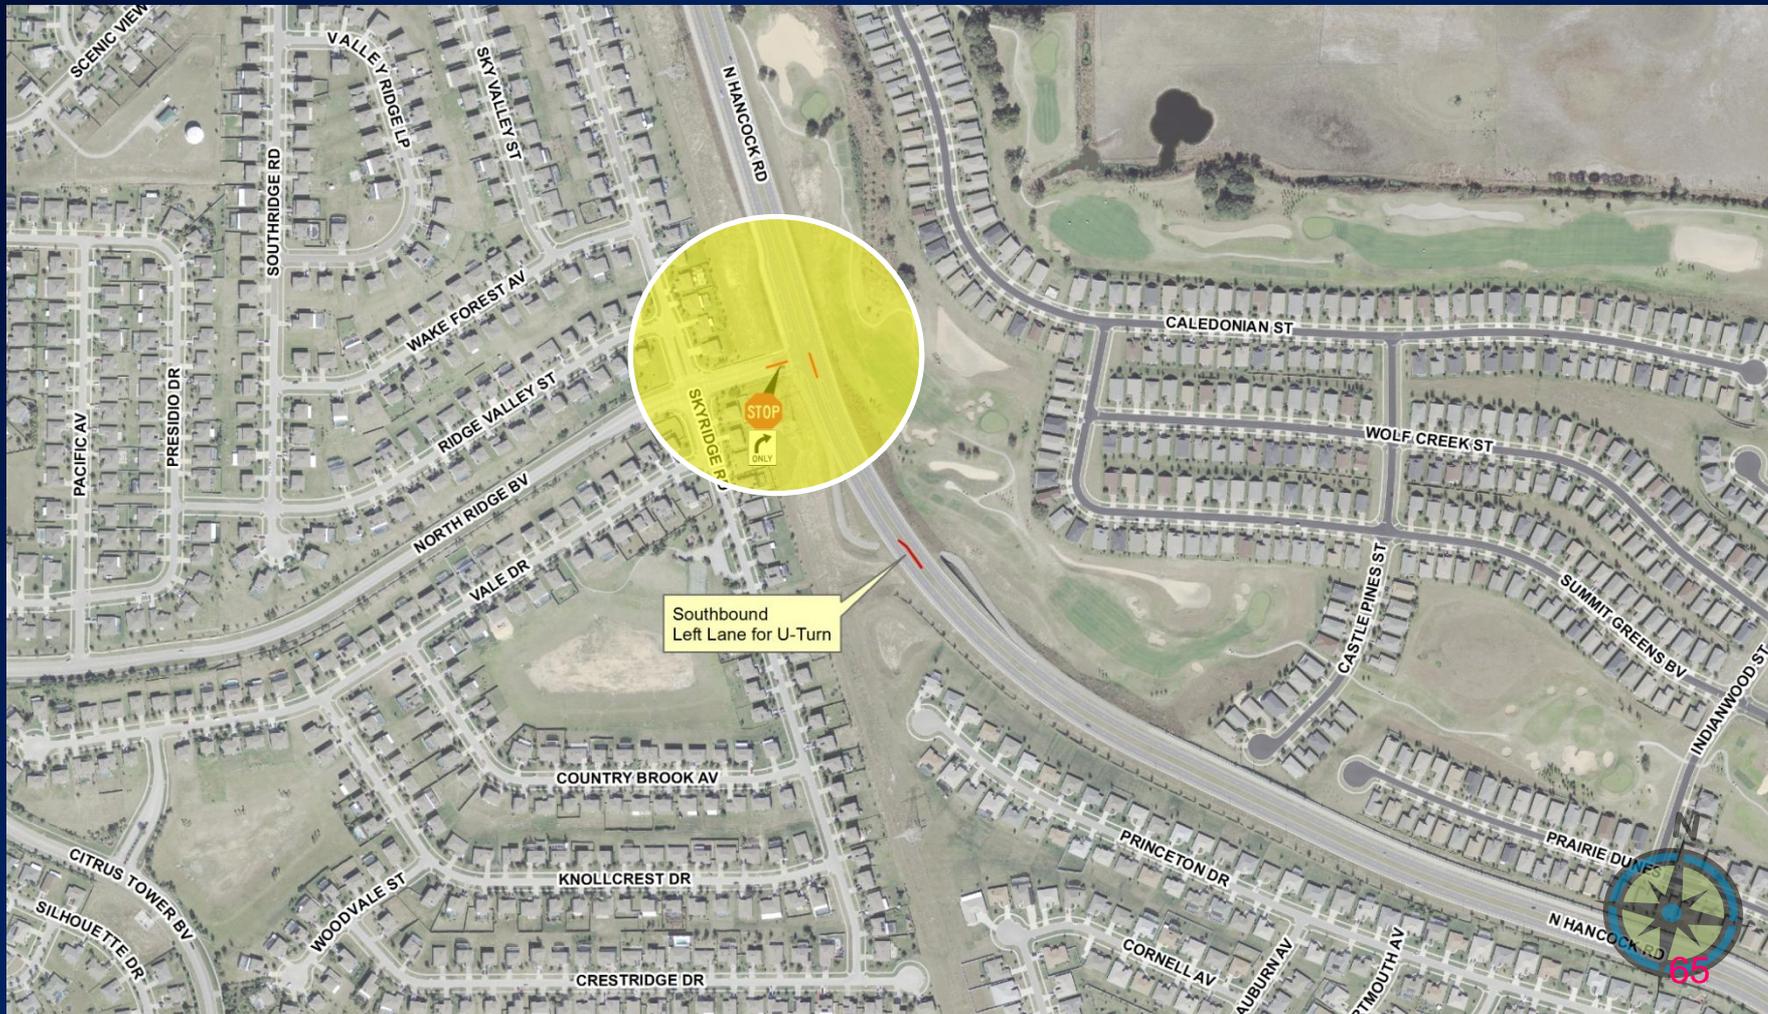
North Ridge Boulevard Possible Corrective Measures

RIGHT TURN ONLY, EXITING NORTH RIDGE BLVD

SOUTHBOUND LEFT TURN LANE FOR U-TURNS

- Cost Estimate
Turn Lane: \$50,000
Directional Median: \$16,000.
