BUILDERS' BEACON

Volume IX Issue 1

Spring, 2005

LAKE COUNTY
BUILDING SERVICES
315 West Main Street
P.O. Box 7800
Tavares, FL 32778-7800

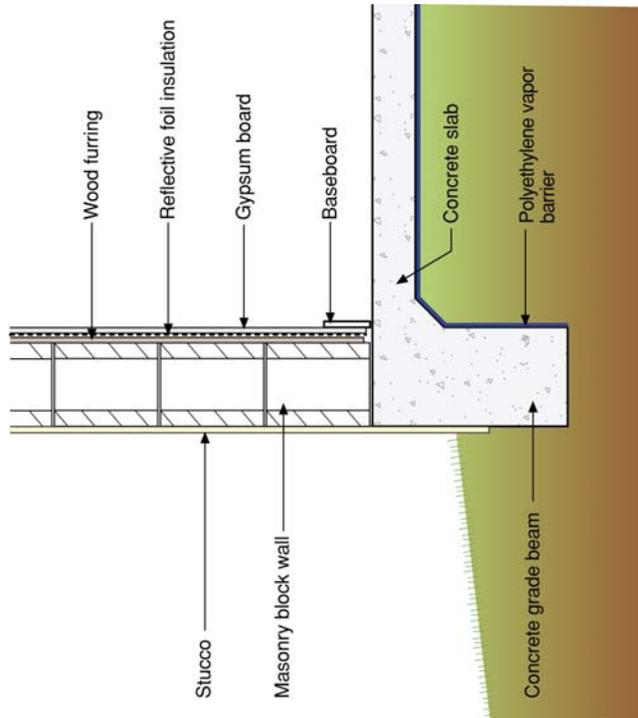
Current practice

Mass Assembly Walls

The second floor assemblies are "drained" assemblies and drain into the first floor assemblies. The first floor assemblies are "mass" assemblies where penetrating rainwater is stored in the mass of the concrete block until it is released to both the interior and exterior during "drying" periods.

The performance of a mass assembly is based on a "rate-storage" relationship. When the rate of wetting exceeds the rate of drying accumulation occurs. Accumulation of water can occur until the quantity of accumulated moisture exceeds the moisture storage capacity of the assembly. The moisture storage capacity is time, temperature and material specific. Under normal conditions the amount of penetrating rainwater through stucco into a masonry block wall is minor and easily absorbed, redistributed and released to both the interior and exterior.

In the mass assemblies water penetrated the stucco via micro cracks (as the water also did in the frame assemblies).

Typical paint finishes are unable to span micro cracks. Under normal conditions this is not an issue for the reasons previously mentioned (the huge moisture storage capacity of masonry block assemblies). As stucco buildings age and are successively repainted the water entry is reduced after each layer of paint is added. In general, this is why many older buildings constructed with mass walls performed somewhat better.

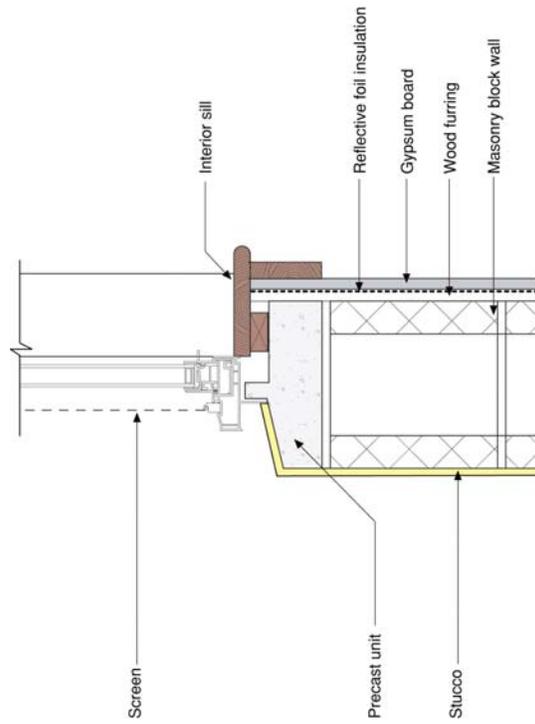
Current

Windows

Windows and doors are expected to leak during hurricanes; they are not expected to blow out.

However, our testing indicates that many windows leaked at conditions well below their rated value – i.e. under no wind condition.

Finally, with respect to windows and doors, it is our contention that the installation instructions regarding window and door installation are inadequate with respect to water management. The windows and doors themselves under the Florida Building Code are subject to an ASTM standard. The interface between the window and door and the wall assembly is currently not.

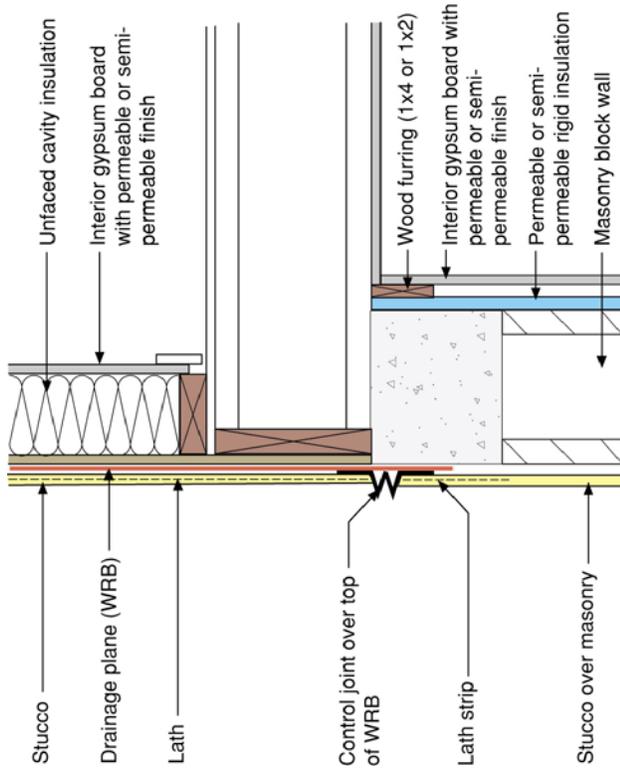
Drained assemblies (joints between 1st & 2nd floors & gable ends)

Current practice (Reversed flashed)

- drainage was poor due to the failure of plastic housewraps and other WRB systems to provide drainage and water holdout.
- drained rainwater was not expelled to the exterior at the base of the second floor frame assemblies.

In the second floor frame assemblies, water also penetrated the stucco via micro cracks. Again, as previously mentioned, typical paint finishes are unable to span micro cracks. In frame wall assemblies it is expected that this penetrating water will be drained back to the exterior. However, in many cases the penetrating rain-water was not drained to the exterior due to adhesion between WRB's and the stucco renderings preventing drainage between the stucco renderings and WRB's, a loss of water repellency of the WRB's and the lack of effective flashing at the base of the drained assemblies.

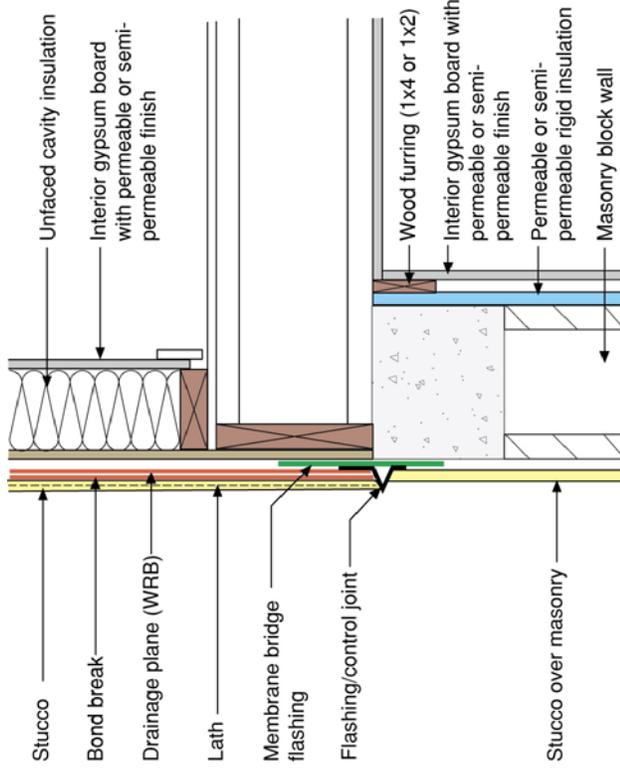
Recommended practice (Drained to exterior)

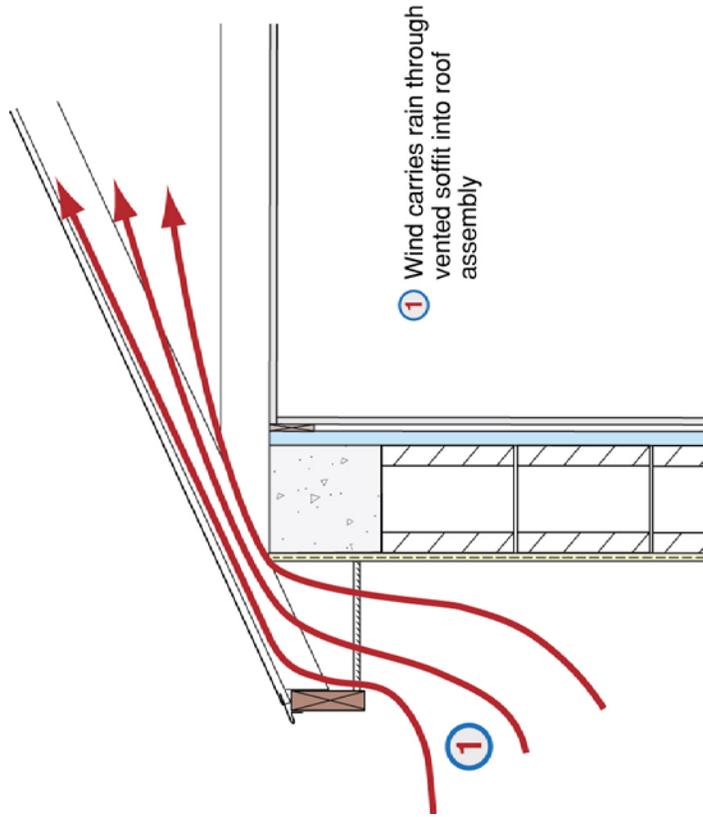
Current practice

Soffit assemblies

The past weather events have produced soffit "blow-outs" in numerous homes. Contractors are cautioned to review and comply with the installation instructions for this construction component. Absence of soffit materials allows wind driven rain into the attic space causing unwanted damage.
